All Saints church HAWSTEAD Suffolk (Diocese of St. Edmundsbury & Ipswich)

Conservation survey report on the monument to Sir Thomas Cullum, first Baronet, erected circa 1675, by Diacinto Cawcy

October 2021

Revision 1 - 27 November 2021

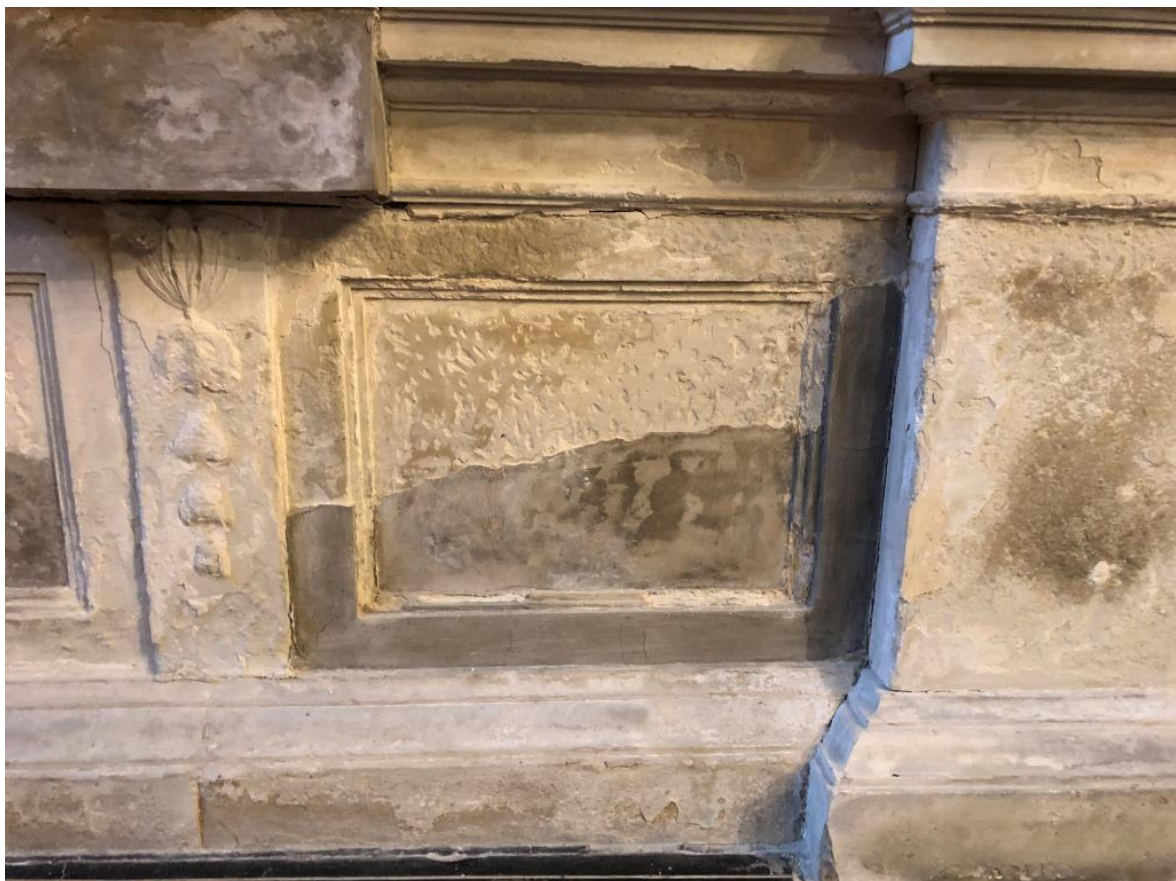
Plate 12: Detail of the centre and left part of the plinth. Note the cement restoration to the centre part of the top course, and the (very weathered) foliage drop to the centre pilaster.

5.2.3 As can be seen from the photos and description in section 3.2.2, the front generally is in poor condition. Plate 12 on page 16 shows the centre drop of foliage having lost definition higher up, and the general surface loss, presence of soluble salts and previous repairs – including some large, very hard, cement patches can clearly be seen. The central part of the upper plinth moulding has two vertical fractures to the front – and there are ferrous fixings below. The squared block, made up in cement and I am sure a much simpler feature than what it replaces, now has extensive fractures and is failing. In fact it wouldn't take much of a knock and the cement would simply fall off.

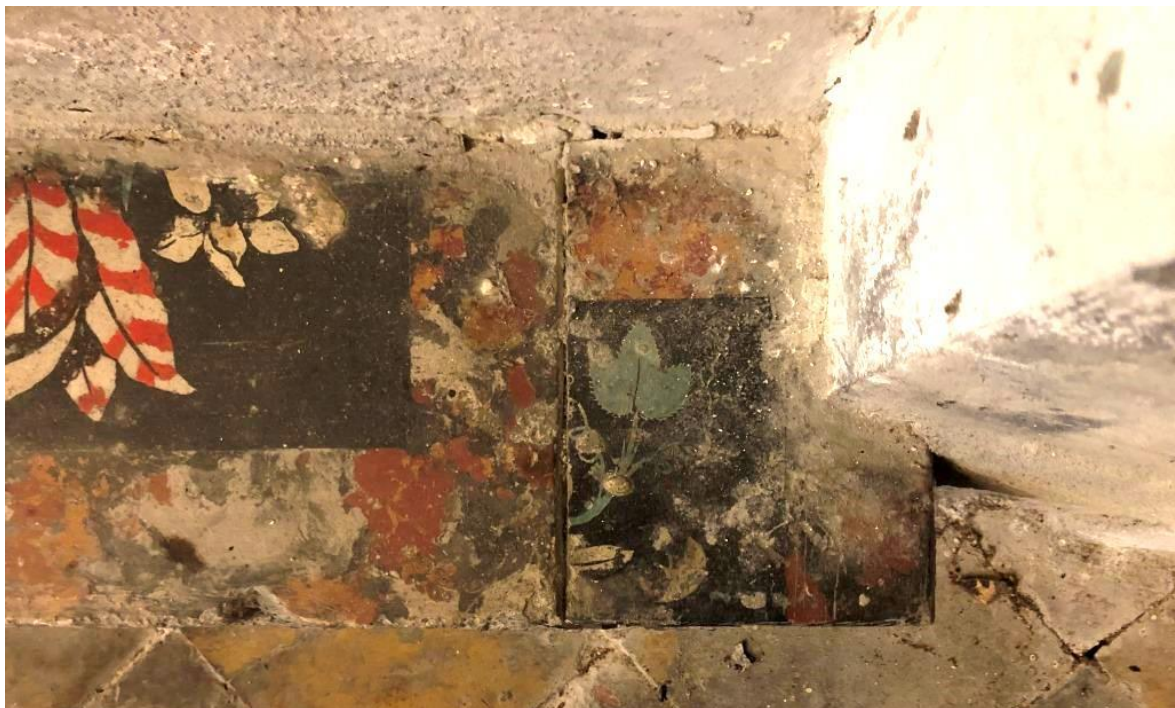
This panel, which looks like it may have originally been part of panel 3 when complete, is relatively unworn but has a very dirty surface, both with ingrained surface dirt and lots of mortar smears. There are open joints to the sides.

Plate 30: Panel 1 is on the right, part of panel 2 to the left. The wall plaster above panel 1 is different to the general wall plaster and has hints of black below the white limewash. I suspect this is original, and contemporary with the monument, and that the black could be an intentional 'shadow' framing the monument.

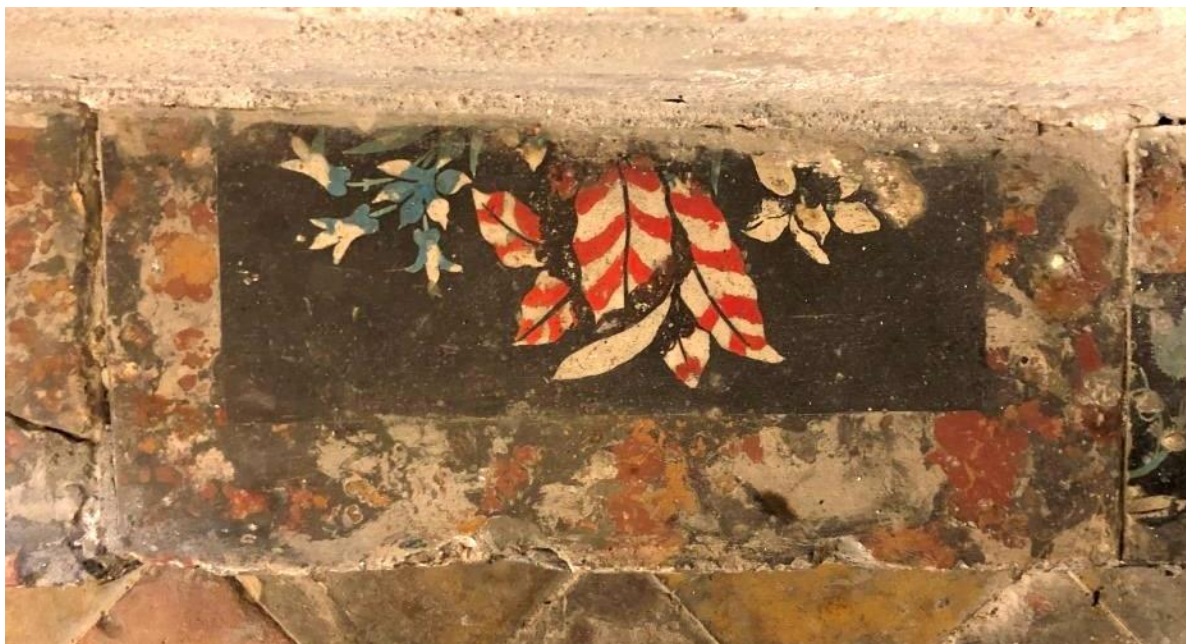
Plate 31: Panel 2.

This is on the corner and is an incomplete version of Panel 4. It is now in 12 pieces, with old cement repairs, but many of the pieces now being loose and poorly fixed. It has moderate wear, but is quite dirty.

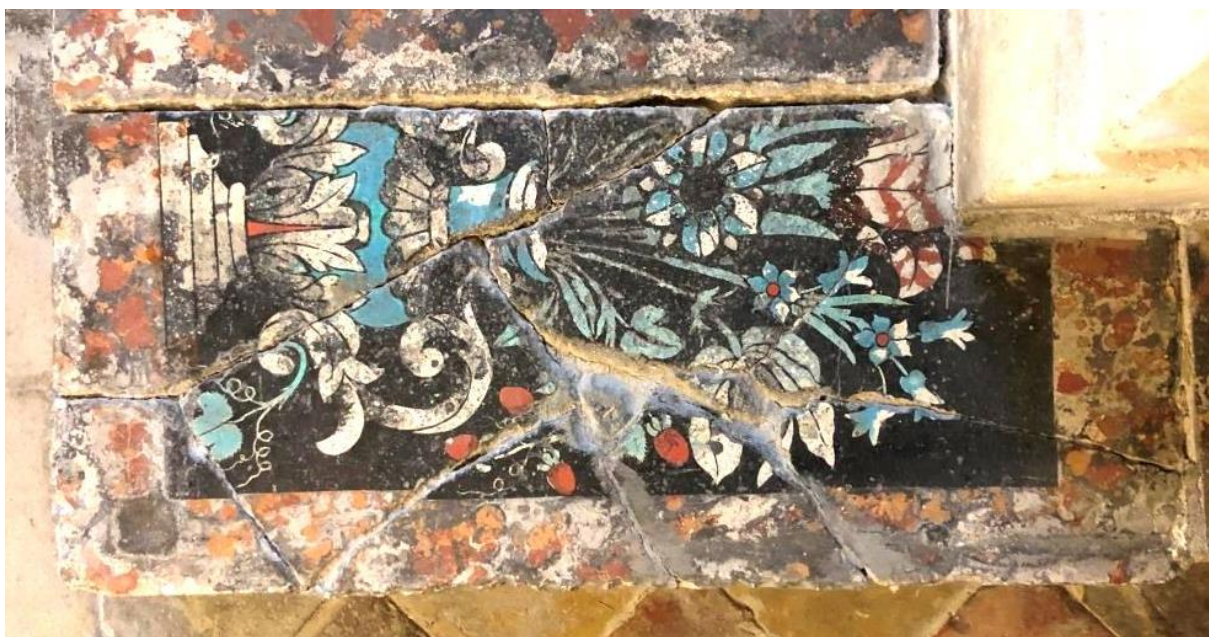
Plate 32: Panel 3, which is badly broken up and has been previously repaired with cement.

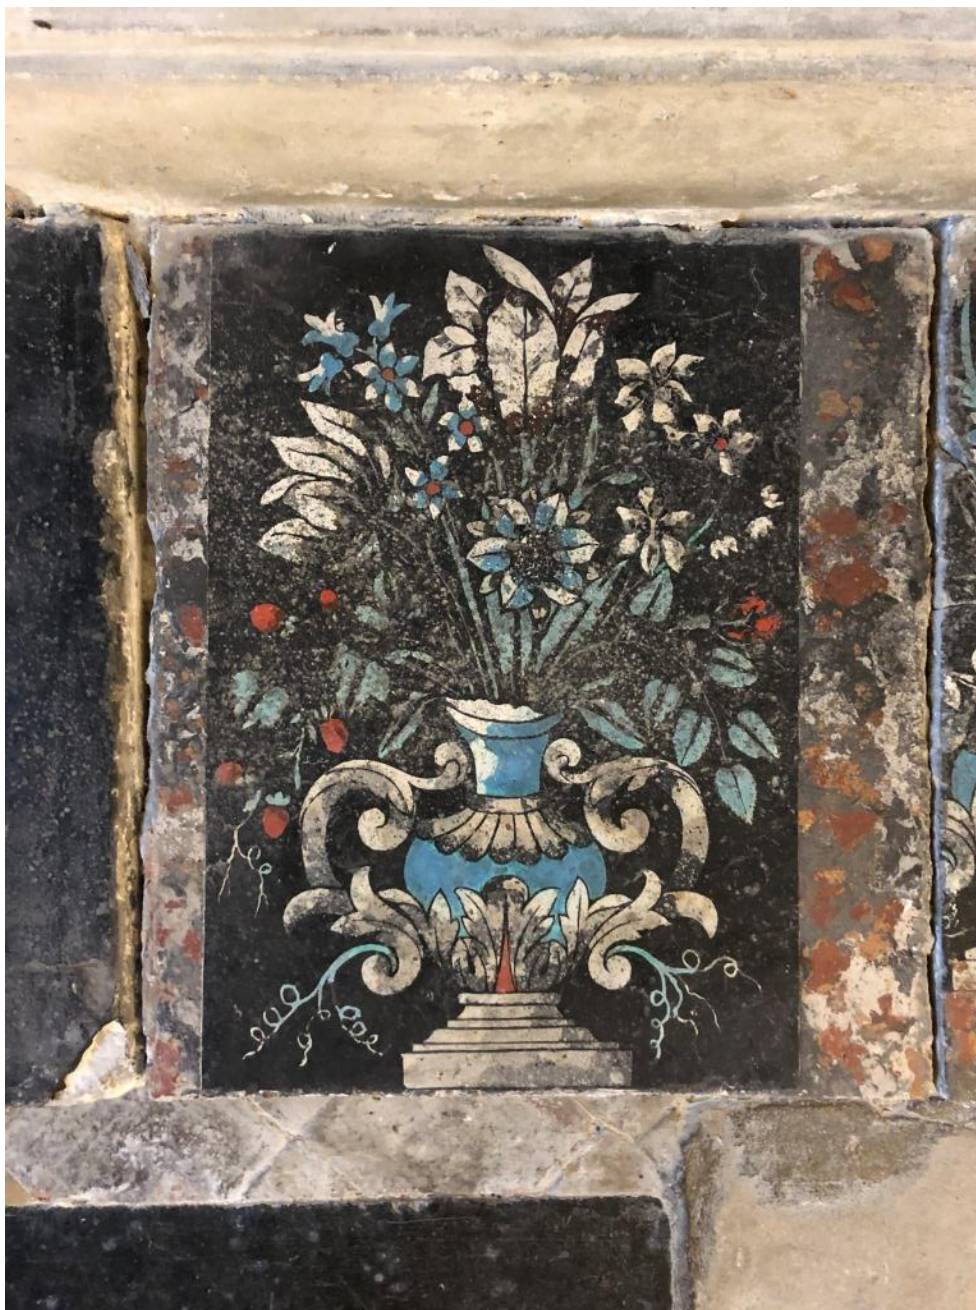
Plate 33: Panel 4.

This panel is complete as one piece but is poorly bedded, and rocks from side to side under gentle pressure. It could easily be lifted out and is thus vulnerable to theft.

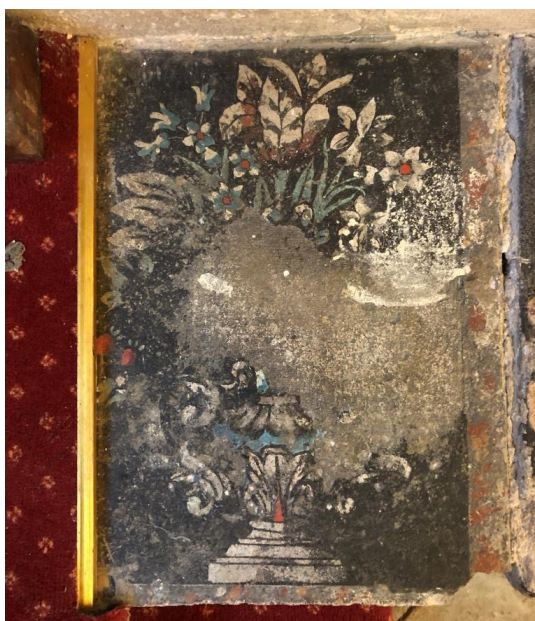
Plate 35: Panel 6.

This panel is complete and feels firm but the pointing to the right-hand edge is poor. It is very worn. It is part covered by carpet, which is almost certainly glued down.

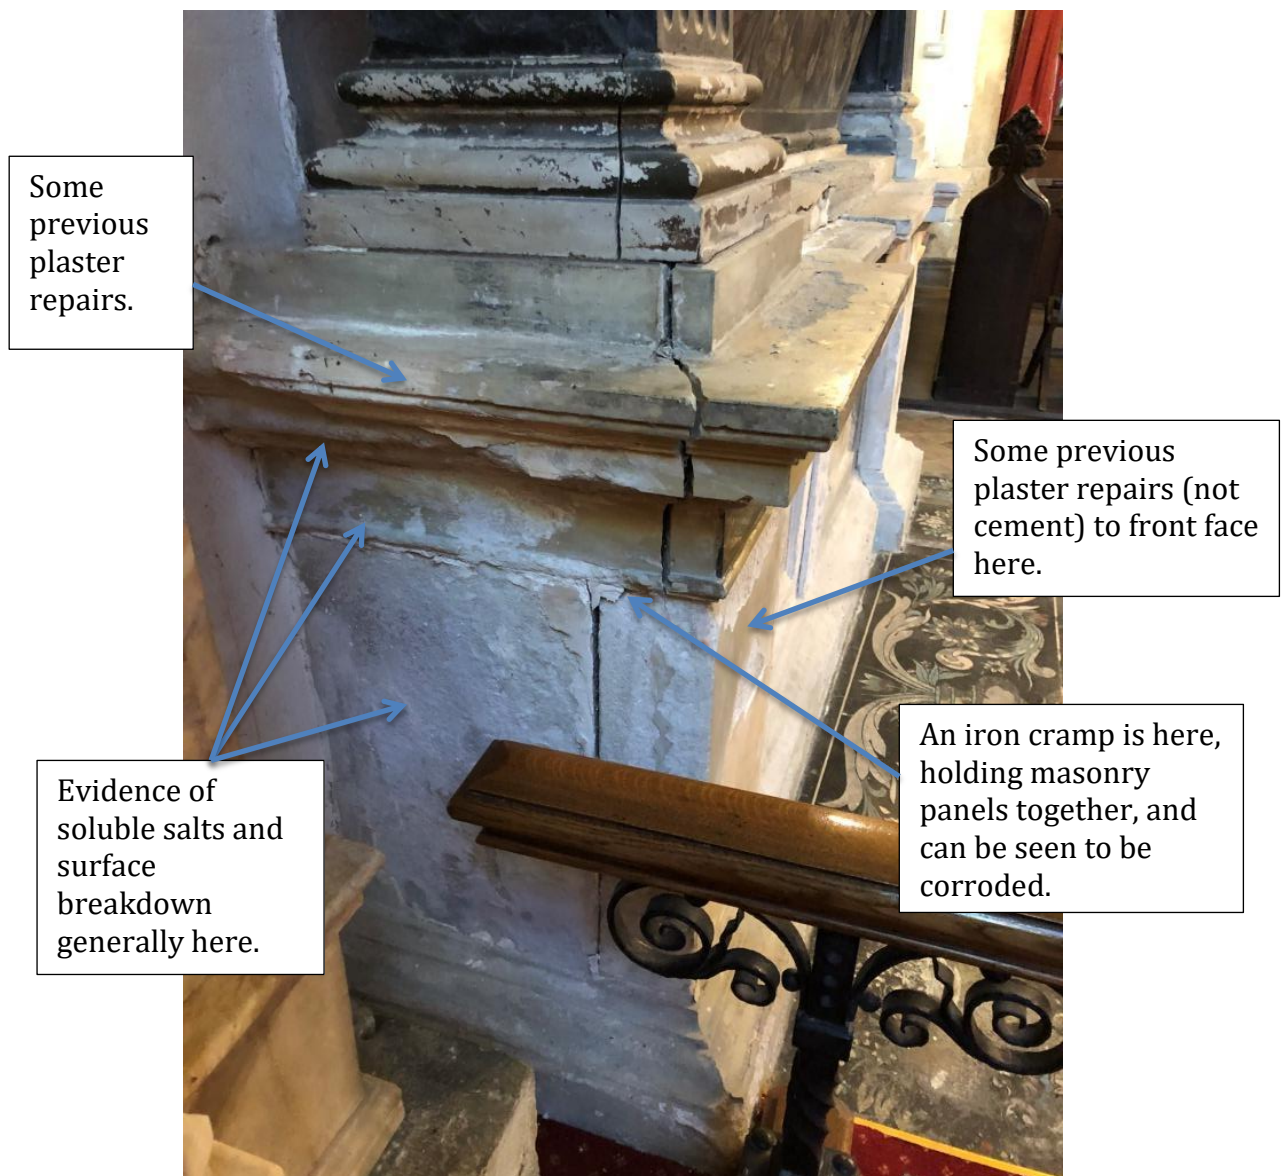
5.2.2 The most concerning aspect of the structure of the plinth is the set of open joints and cracks to the left-hand return. The joint between the main panels on this side is barely open at the bottom, but by the top is open by 5mm, and in the top moulding is echoed by a fracture through a stone element – which continues to be visible in the column base above. See plate 36 below.

Plate 36: The left-hand return of the plinth. The cracks and fractures are described in the text above.

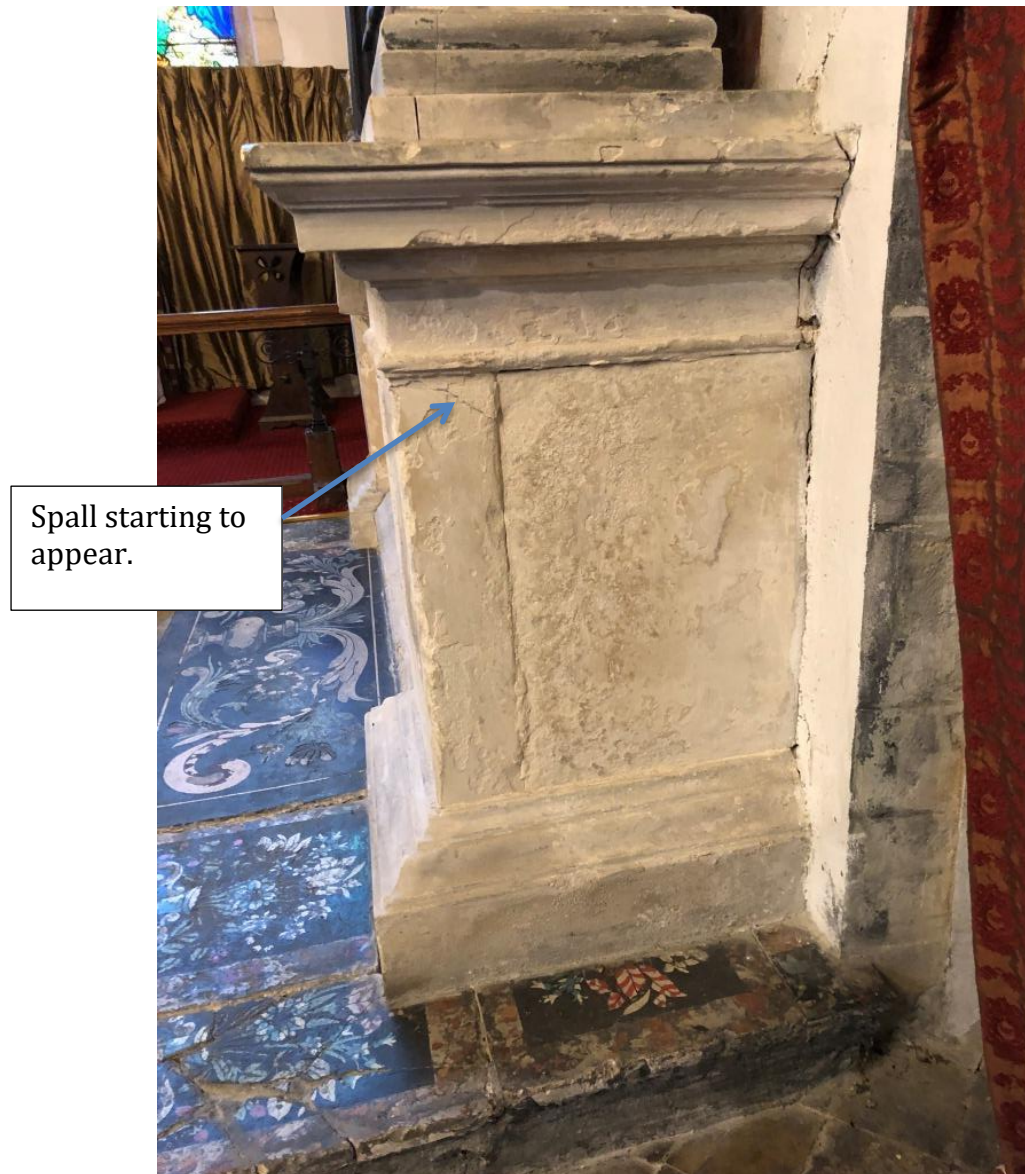
- 5.2.4 The right-hand return, fortunately, doesn't exhibit the same degree of structural disruption as the left. However there is a slightly open joint between the plinth and the wall, extensive surface deterioration generally, and the iron cramp tying the main panels together (picked up in the metal detector survey, see section 3.2.2) has its presence further given away by a stone spall starting to appear.

Plate 38: The right-hand (west) return of the plinth.

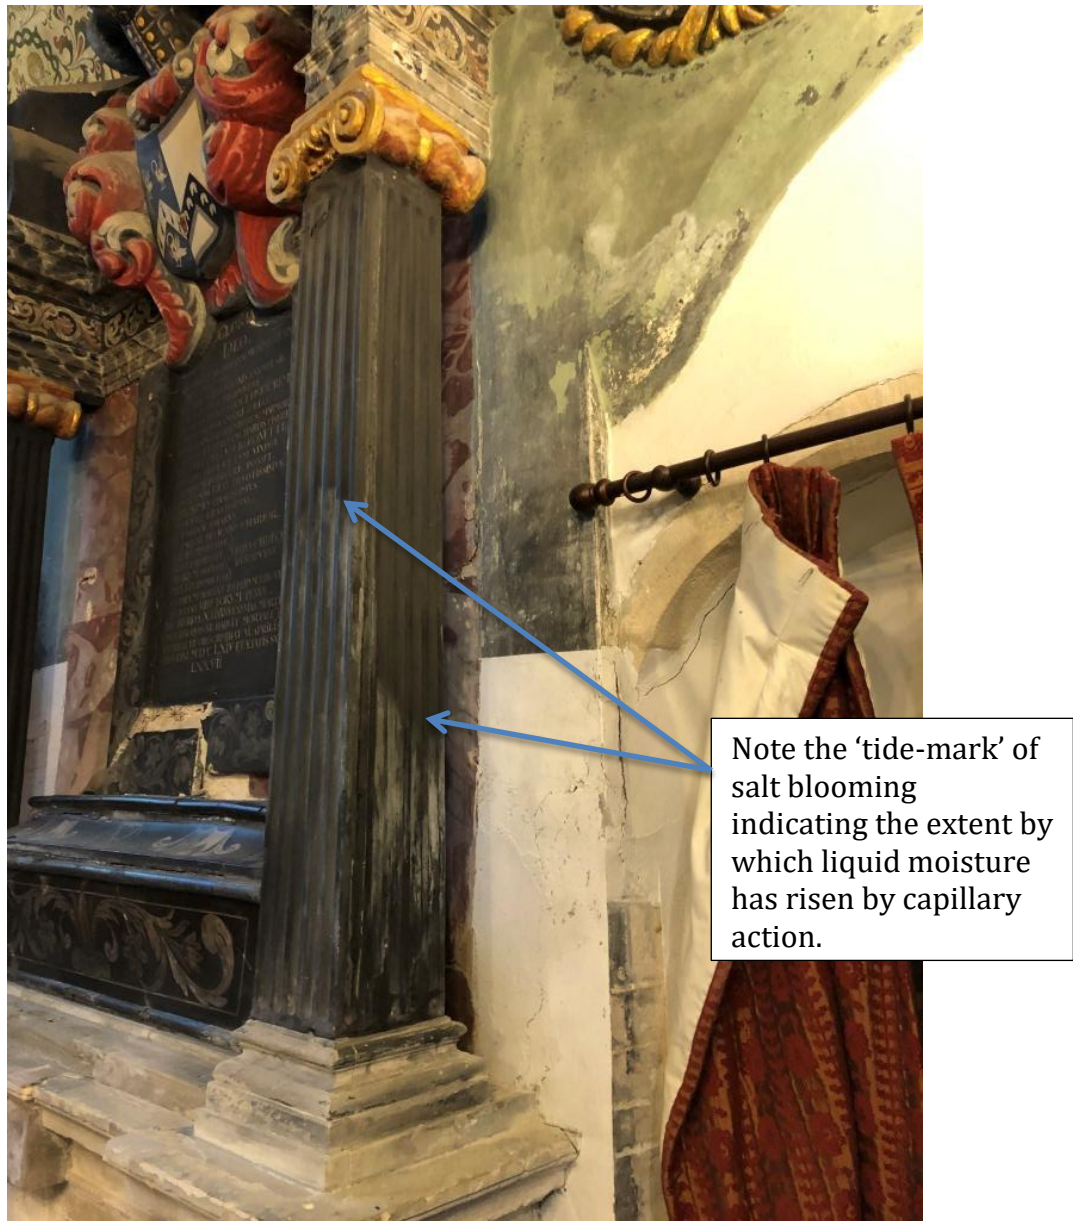
- 5.3.1 The stone 'slab' below the sarcophagus is in poor condition, and has been repaired many times by making good with various different types of plaster and cement. See plates 37 & 41.
- 5.3.2 The columns generally have been previously repaired, as we have seen, but now appear relatively stable. What is interesting is that there is what is effectively a 'tide mark' from where salts have bloomed where liquid moisture has risen up each column by capillary action, clearly coming from below – i.e. from the ground. See plate 39, below.

Plate 39: The right-hand (west) column.

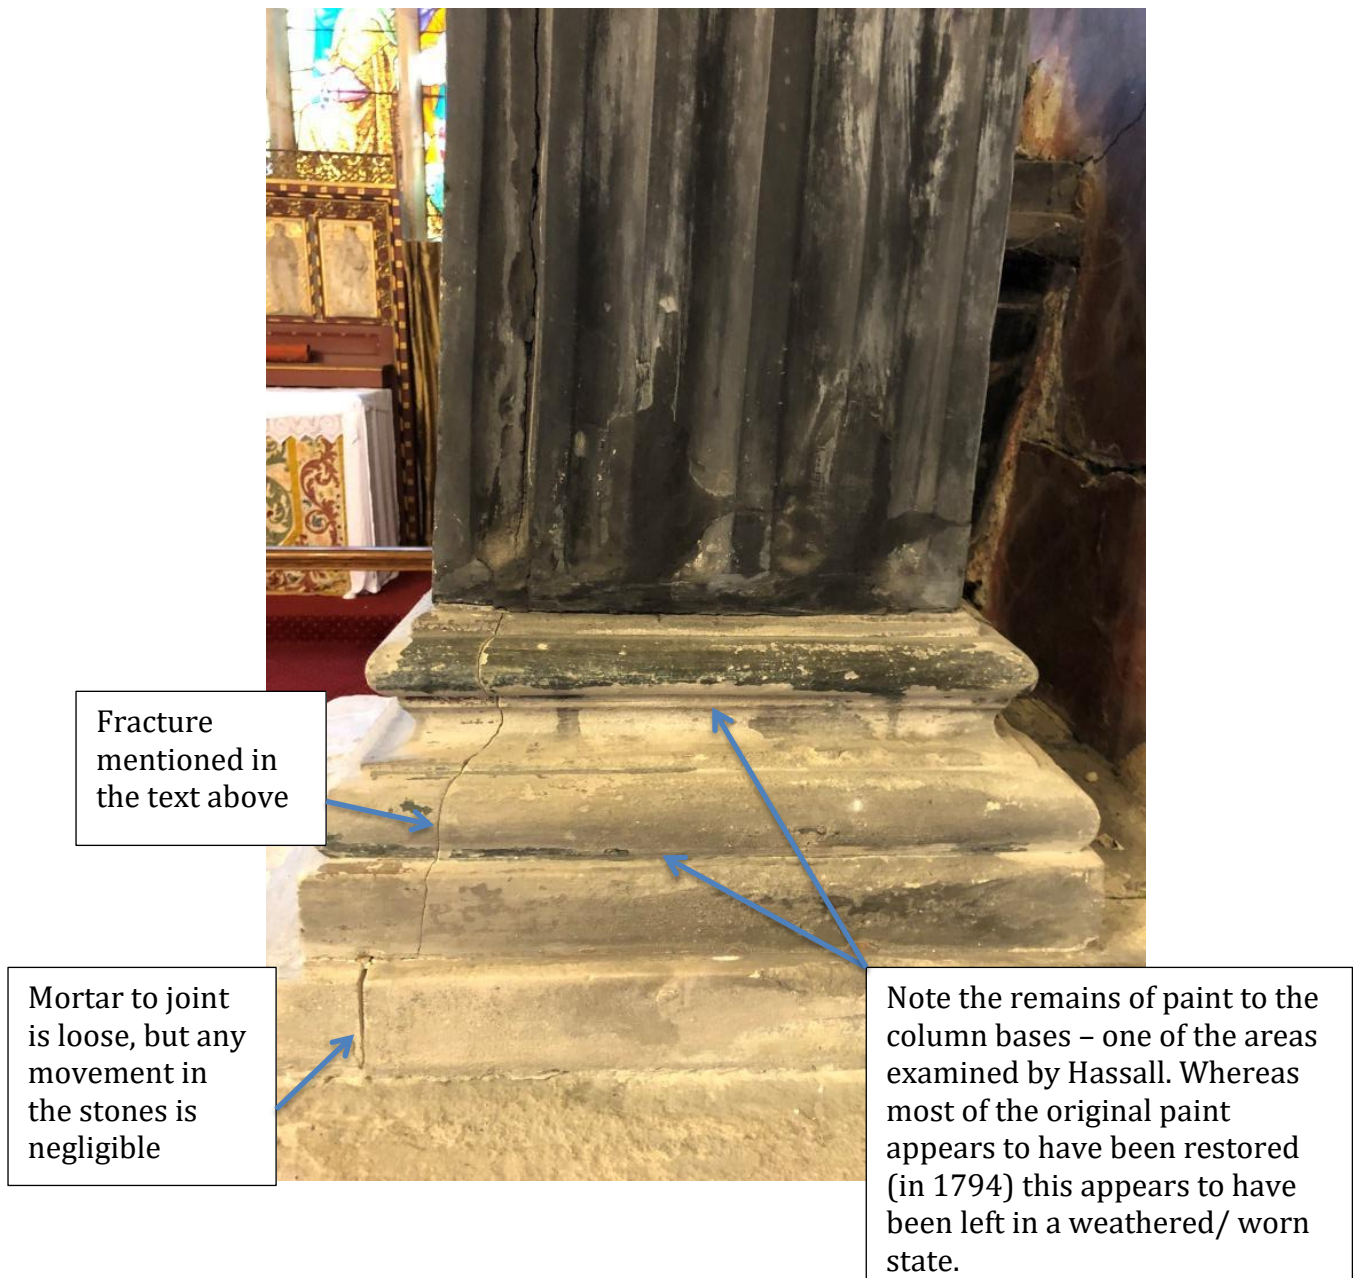
- 5.3.3 It has already been noted how the left (east) column base has slightly opened up at the joint between the stones (plate 36, page 38). The right column base however has also been disrupted, but in a slightly different way. Here the surrounding stonework is more correctly aligned, but a fracture has appeared vertically through the column base. There has been particularly extensive making good of the base below the sarcophagus on the inside edge of the column base as well, so something has been going on here – but I am not sure what. See plate 40, below.

Plate 40: The right-hand (west) column base, seen from the west.

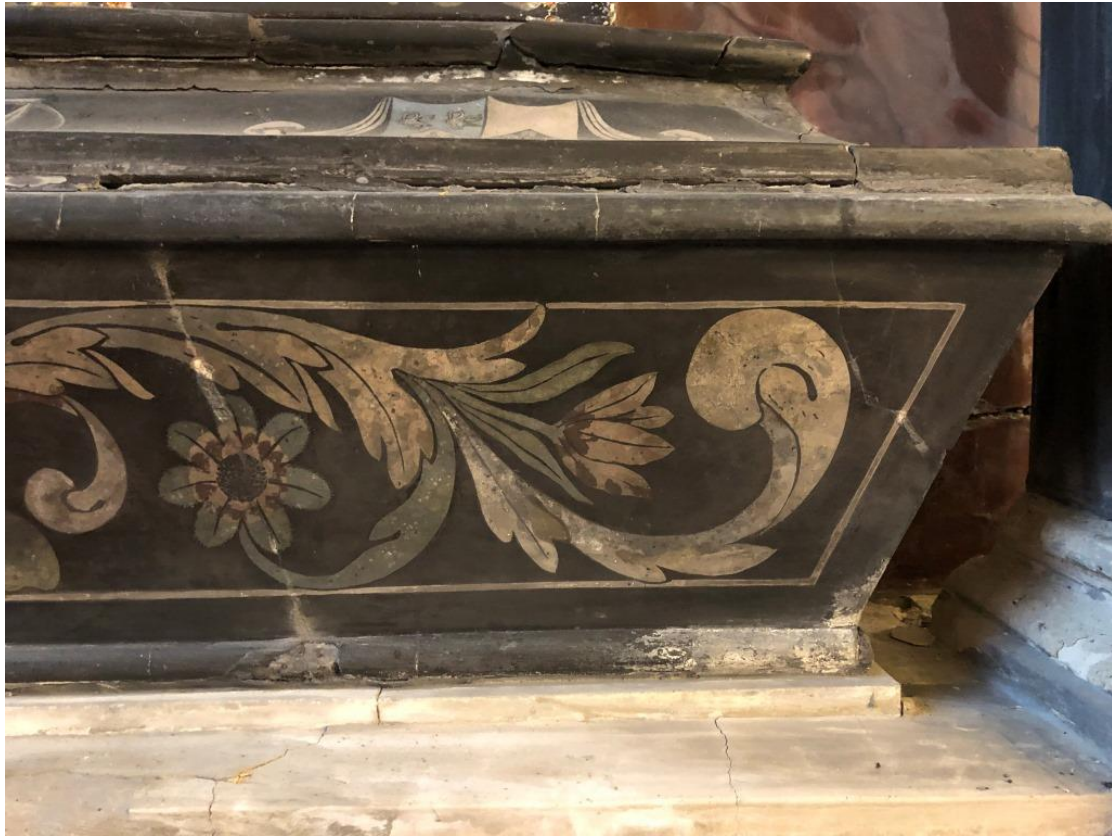
- 5.4.1 The sarcophagus is in particularly poor condition. The main sloping sides have all been badly damaged and extensively repaired, presumably in 1794.

Plate 41: Detail showing part of the front of the sarcophagus. Note the extensive previous repair – the painted finish to which is now faded; and the patchiness to the original coloured paste infill to the scagliola panels. The disruption to the base stones (see section 5.3.1) is clearly in poor condition. Old plaster repairs can also be seen to the adjacent column base. Most alarming however is the massive structural disruption and cracking to the concave moulded upper section and the capping element of the sarcophagus.

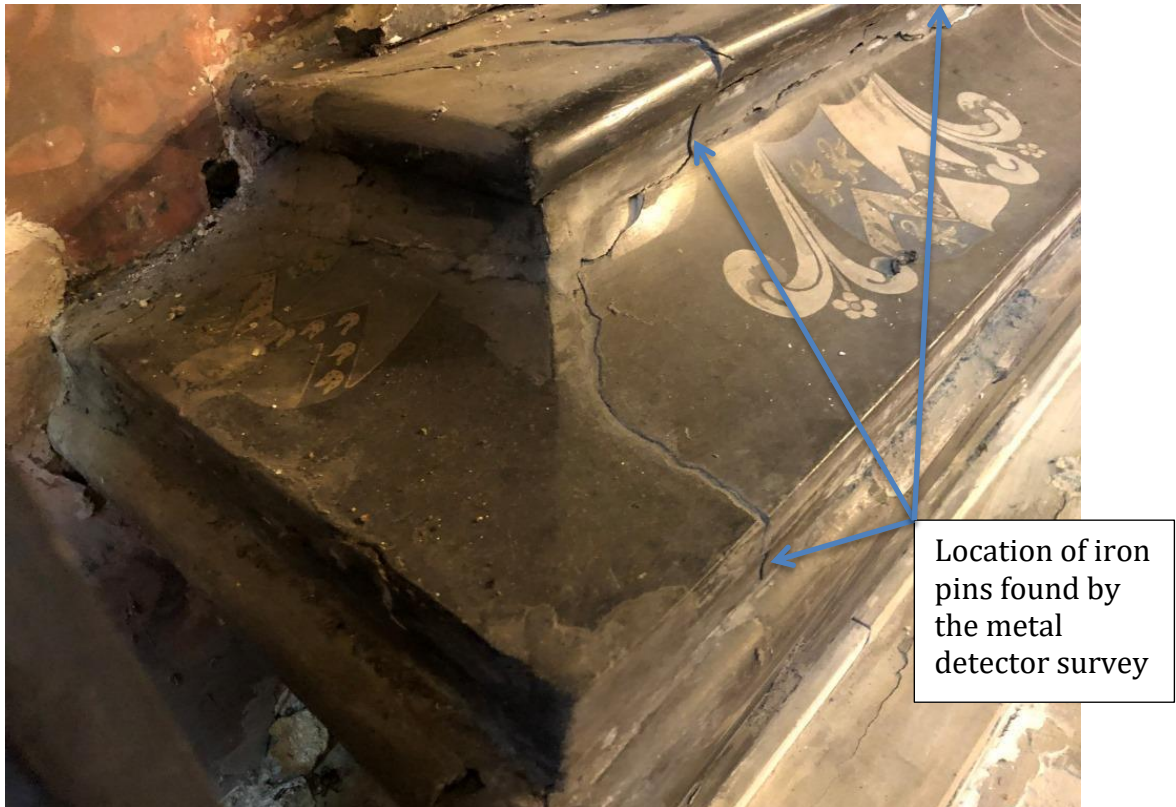
- 5.4.2 As can be seen in the photo above, and in plates 42 & 43 overleaf, there is extensive fracturing to the two upper elements of the sarcophagus. This seems to be largely associated with the locations of iron fixings within the structure, and in the top where some kind of embellishment must formerly have sat (see section 3.2.4).
- 5.4.3 Upper surfaces of the sarcophagus are particularly dirty with a build-up of dust (very clear in plate 43), with other surfaces of the monument generally with varying degrees of imbibed dirt.

Plate 42: Detail of the upper parts of the sarcophagus, showing cracking and structural disruption associated with the location of ferrous fixings.

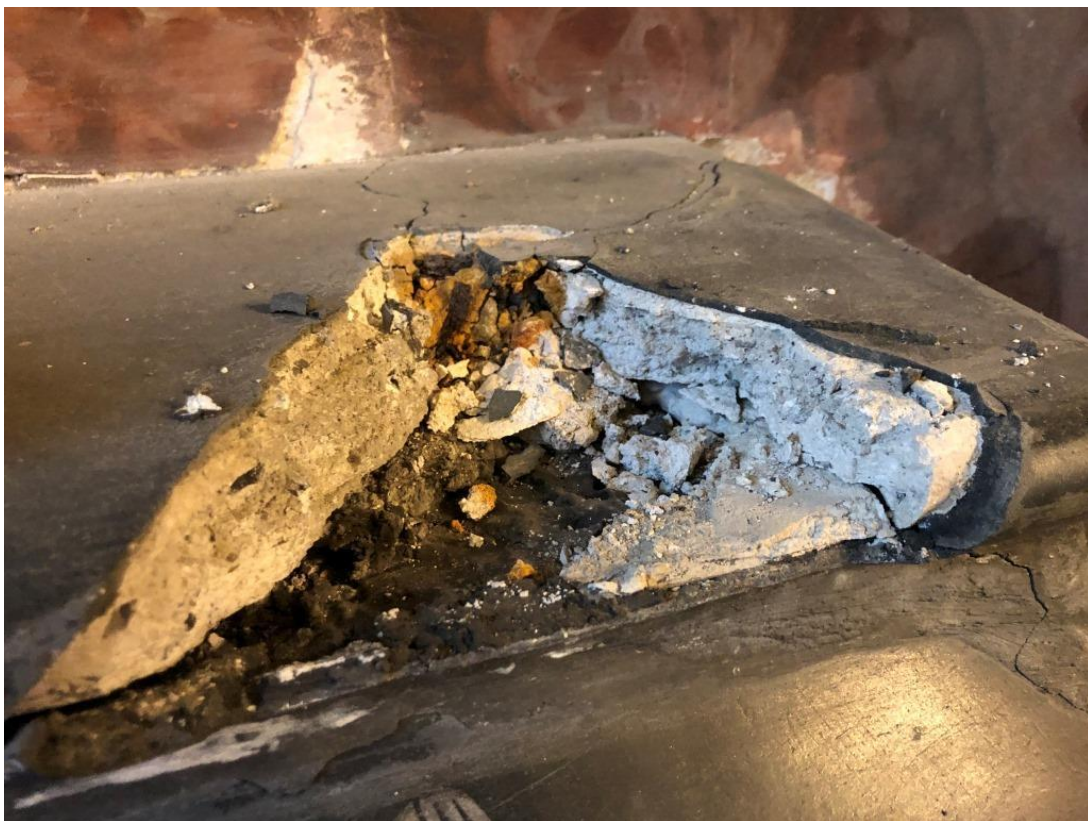
Plate 43: Detail of the top of the sarcophagus, right-hand side. A loose piece has been removed to show the construction of these panels with black scagliola over a coarse plaster base (not stone here), and the remains of one of three old iron fixing pins in the top. The expansion of the corroding iron can very clearly be seen to be the epicenter of structural disruption and cracking.

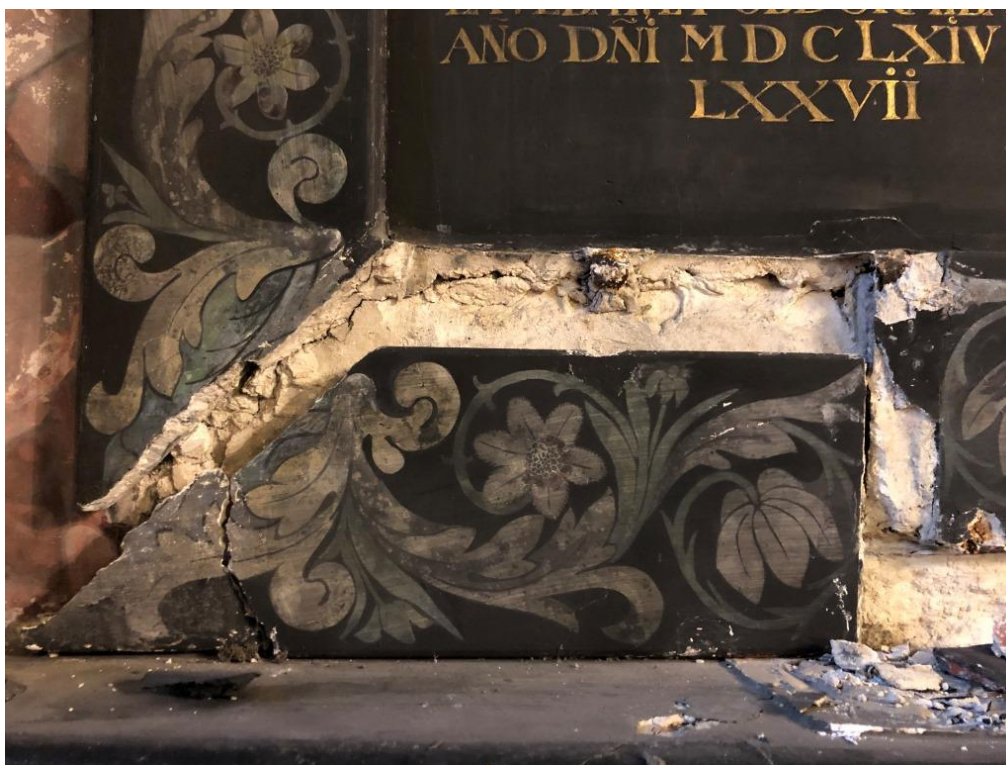
Plate 44: Where the lower parts of the frame have come away the corroding iron cramps, and sectional make-up of the frame, can be clearly seen.

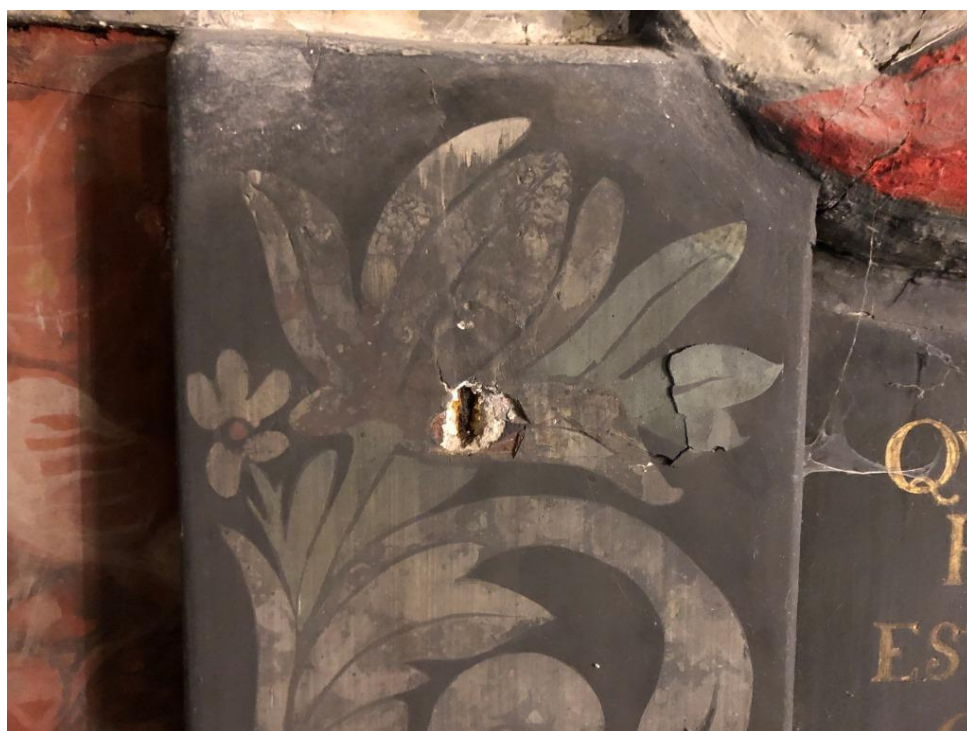
Plate 45: Iron pins – which exactly correspond on the other side – near the top of the frame are also causing disruption including, here, flaking of the plaster surface.

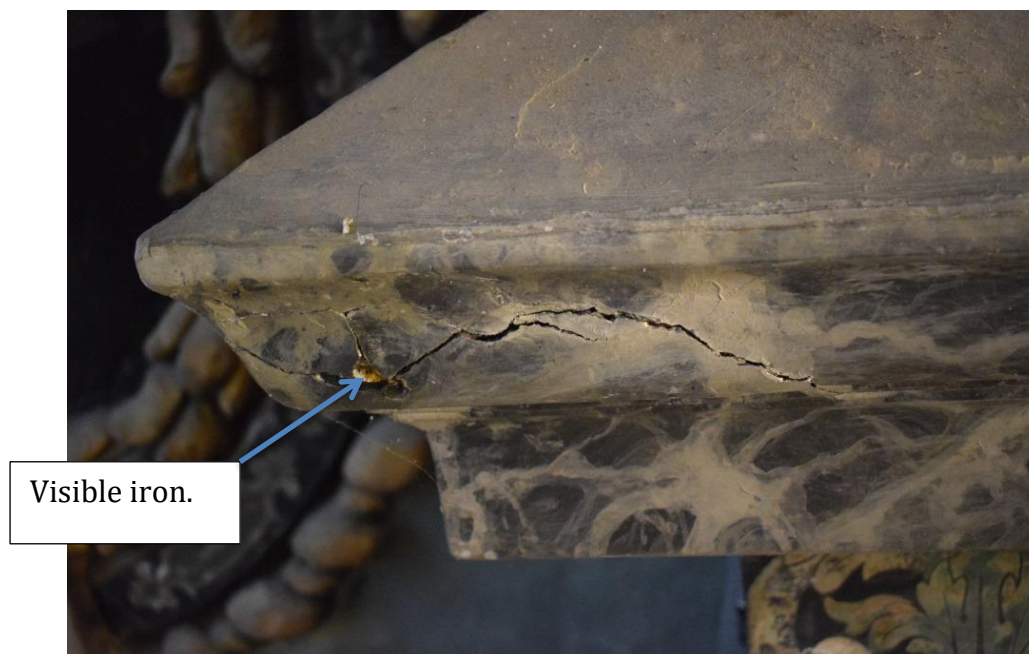
- 5.5.2 The cornice can be seen in detail in plates 19 and 20. There are two main issues of concern. Firstly, as we have seen in section 3.2.5, the cornice is made up of large pre-formed units with iron reinforcement, and in places there is localised surface disruption where this is corrosion. See plate 46. Secondly, there are localised fractures associated again with ironwork, but this time with fixings holding panels in place. See plate 47.

Plate 46: Localised surface disruption and cracking to the cornice where a section of iron reinforcement is corroding.

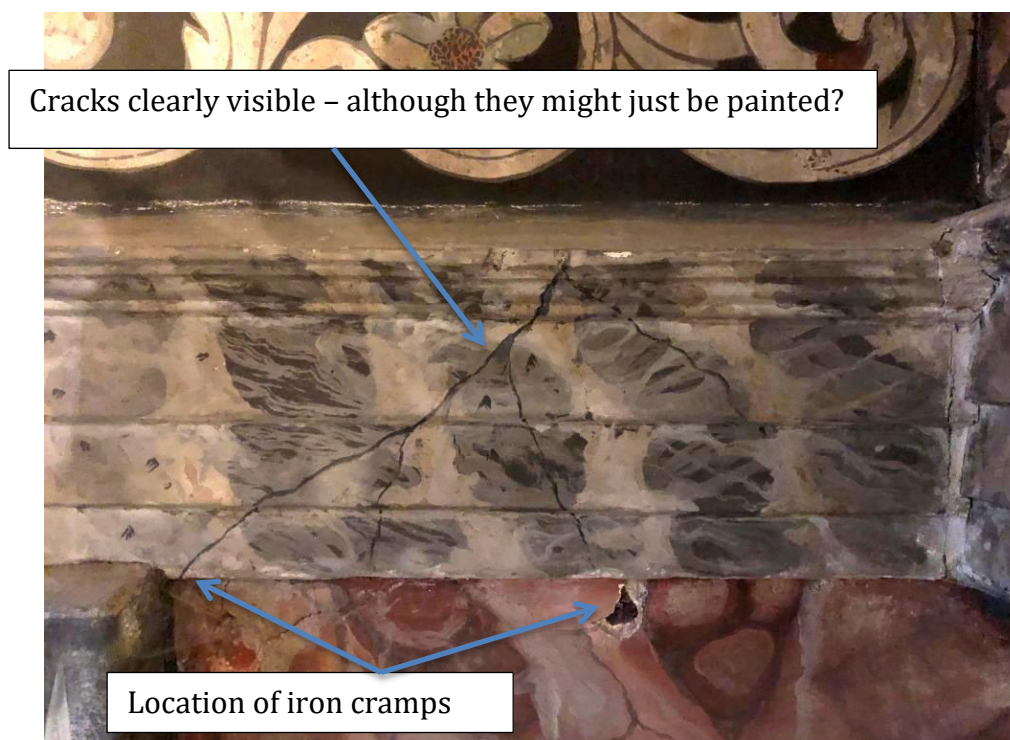
Plate 47: Fractures to the architrave to the right of the centre, showing the position of iron fixings below.

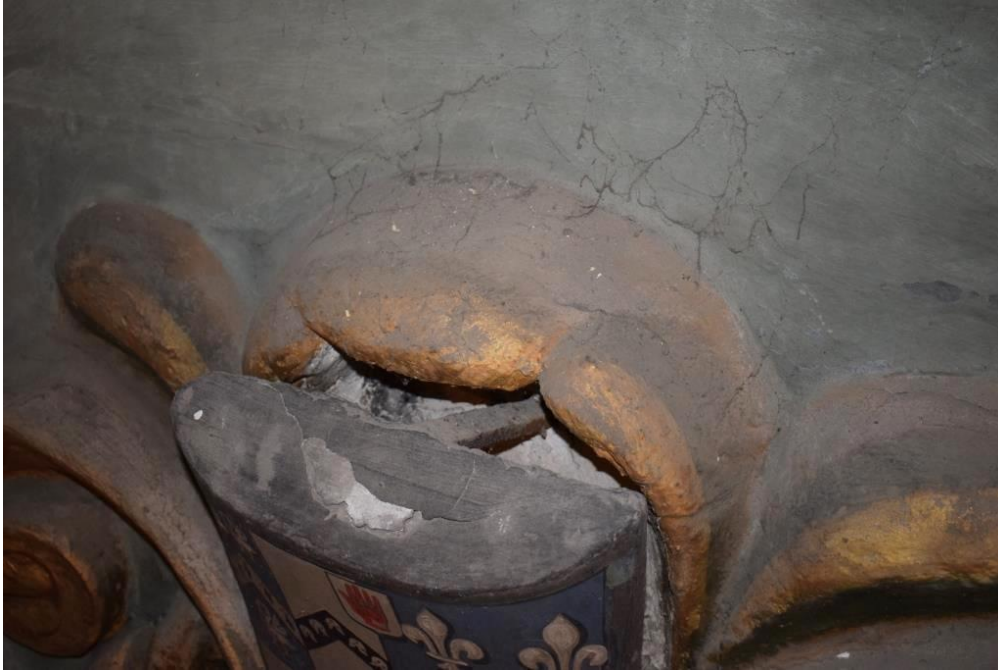
- 5.6.1 As previously noted for the sarcophagus, upper surfaces of the cartouches are particularly dirty with a build-up of dust.

Plate 48: Detail showing the top of the shield above the left-hand cartouche. Two things to note here are the heavy build-up of dust and spiders' webs on upper surfaces – where the gilding and painted shadows are really quite subtle; and the scagliola shield restrained by an iron cramp. The iron is visible because the shield is angled forwards and is surely representative of what is hidden elsewhere. The only sign of problems with the ironwork is very minor spalling of plaster covering it on the shield.

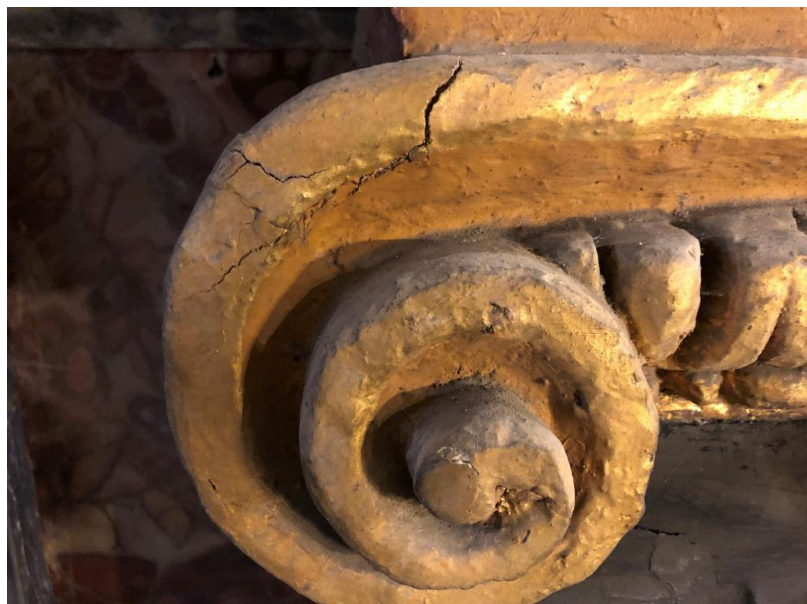
- 5.6.2 As noted with elements lower down, there is localised cracking and surface spalling where there is hidden reinforcement within the plaster or scagliola elements. See plate 49, below, as an example.

Plate 49: Detail showing the capital above the right-hand column where there is some cracking over hidden iron reinforcement. A metal detector survey of this area gives pretty well constant positive readings – it must be full of iron reinforcement.

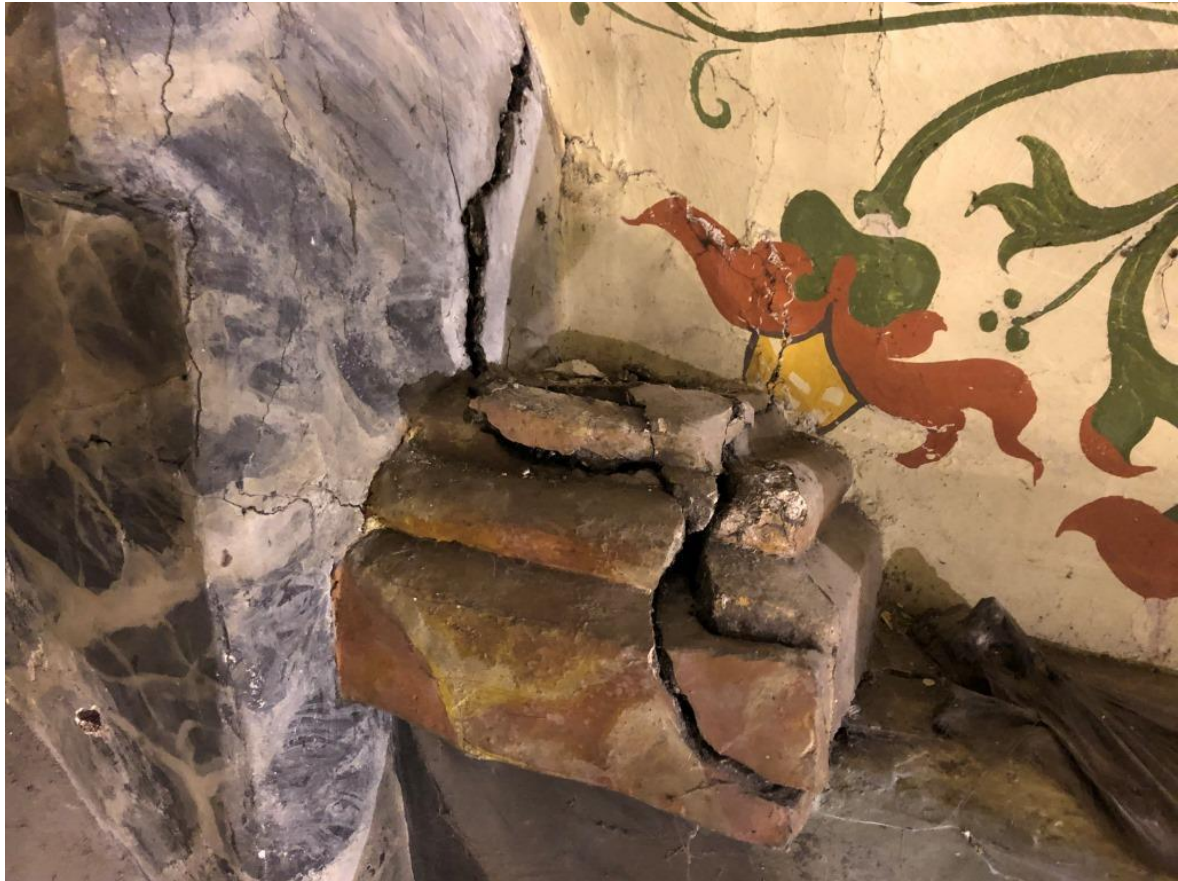
- 5.6.3 There is quite extensive cracking, bulging and movement at the interface of the cartouches and the plaster ceiling. This is pretty well right along the top of the monument, and looks to be on the whole representative of differential movement between the ceiling plaster and the monument rather than the monument itself moving at high level. See plate 50 below.

Plate 50: Detail showing the interface of the wall and the monument bust to the right-hand side of the central cartouche. The cracks and disruption is at the join and has caused a fair amount of disruption.

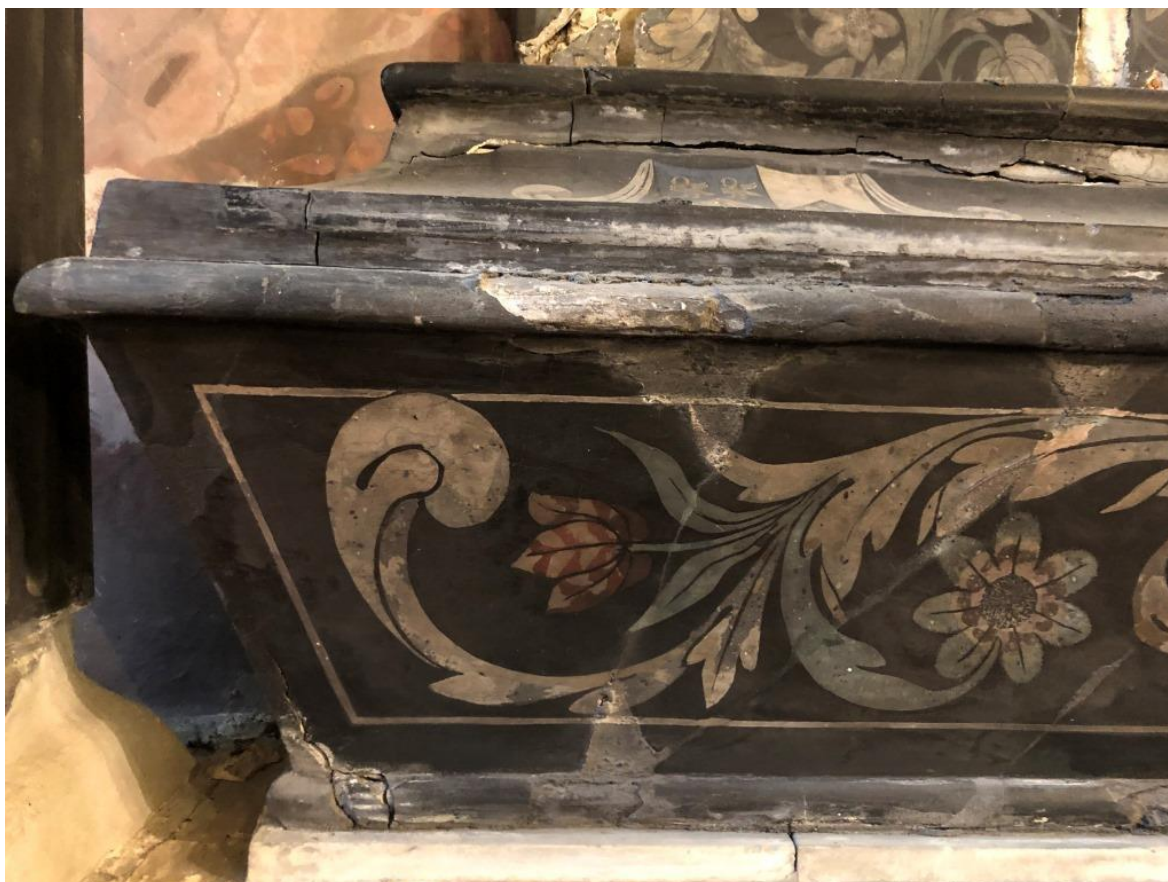
Plate 55: Photograph taken in October 2020 showing the same area. Although the disruption to the top of the sarcophagus was evident 28 years ago, it does appear more pronounced today.
