All Saints church HAWSTEAD Suffolk (Diocese of St. Edmundsbury & Ipswich)

Conservation survey report on the monument to Sir Thomas Cullum, first Baronet, erected circa 1675, by Diacinto Cawcy

October 2021

Revision 1 - 27 November 2021

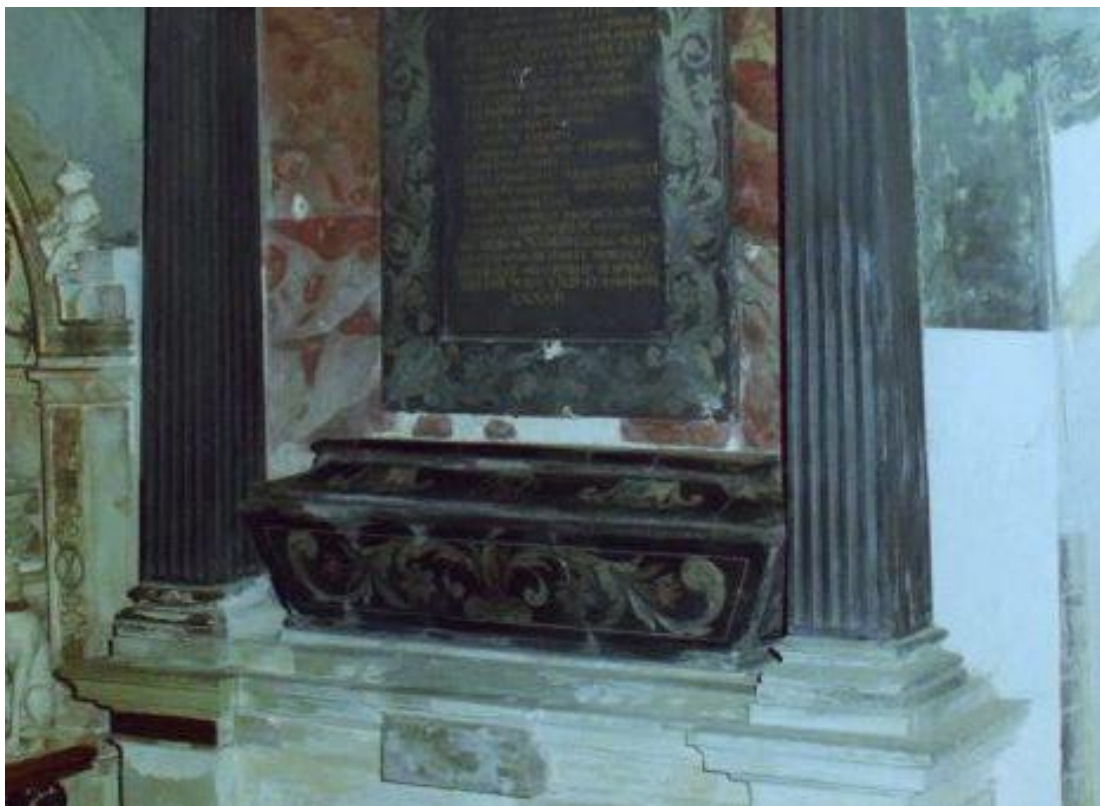
Plate 57: Detail of an image taken by myself on 21 March 1998. The angles are slightly different and there is some shadow in the 1992 photos, but there is not much discernible difference. The spalled plaster on the back panels is already present in 1992 (indicated on plate 56) and the lower frame sections, displaced by 2020 – and indeed in 2016 where shown as such in Simon Swann's report proposal – are still in place.
