All Saints church HAWSTEAD Suffolk (Diocese of St. Edmundsbury & Ipswich)

Conservation survey report on the monument to Sir Thomas Cullum, first Baronet, erected circa 1675, by Diacinto Cawcy

October 2021

Revision 1 - 27 November 2021

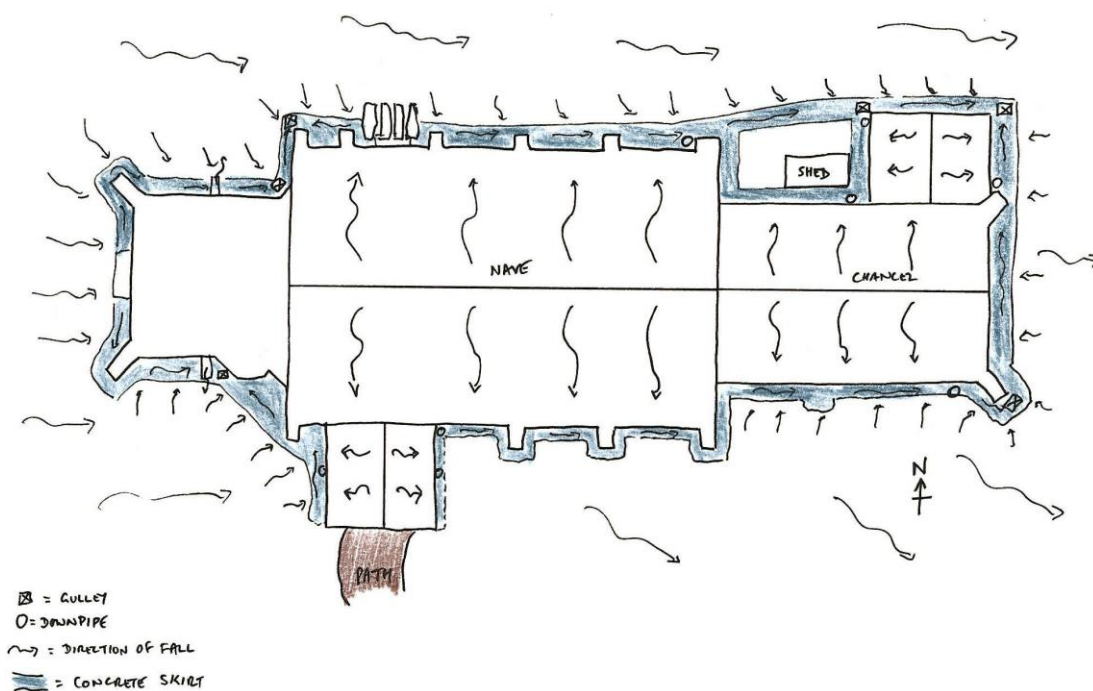
Plate 4: Dispersed water survey.

The purpose of the dispersed water survey is to examine how the building manages rainwater disposal and surface water drainage in the vicinity of the monument. As can be seen from plate 4 above there is a concrete skirt right round the church, interrupted in places by monuments, with the ground sloping down slightly to the skirt, with the slope generally from west down to east, and to the south of the church also to the south-east.

- 2.4.2 The rainwater goods appear to be in good order although I would like to see how the south chancel gutter performs in heavy rainfall. It is a half-round cast iron arrangement, with a downpipe in the south-east corner, which to me just looks a little light to cope with a large roof area. The concrete skirt is functional – it needs to be though as for much of its length it is set well below the general ground level (so effectively lowering the external ground level relative to the floor inside – which is of significant benefit to the moisture content of the wall, lowering it at lower levels inside), with the ground adjacent to the skirt sloping towards it.

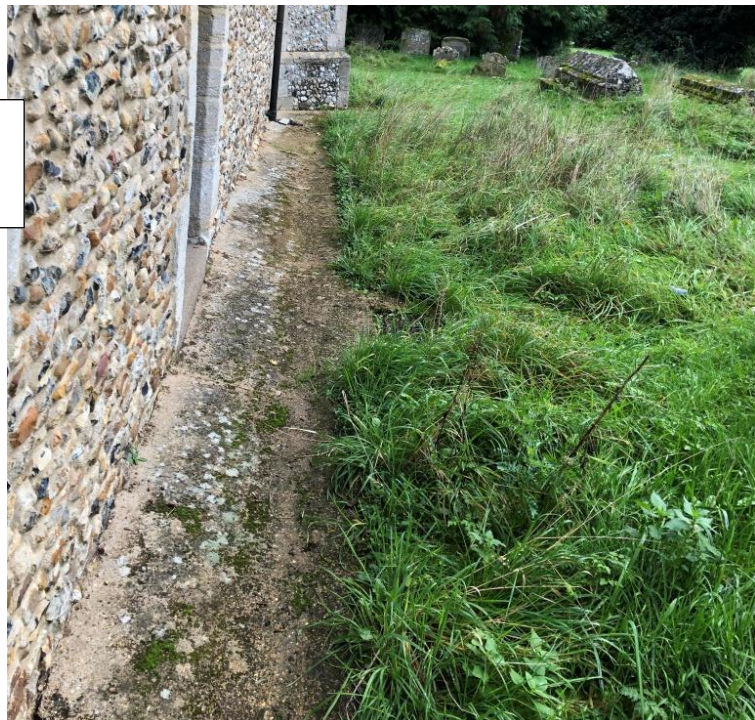
Plate 5: The concrete skirt along the south side of the chancel

- 2.4.3 As can be seen in plates 5 and 6, the level of the skirt is about 200mm lower than the chancel floor level in the vicinity of the monument, although the general level of the churchyard grass is some 300mm higher than the floor. See plates 5 and 6.

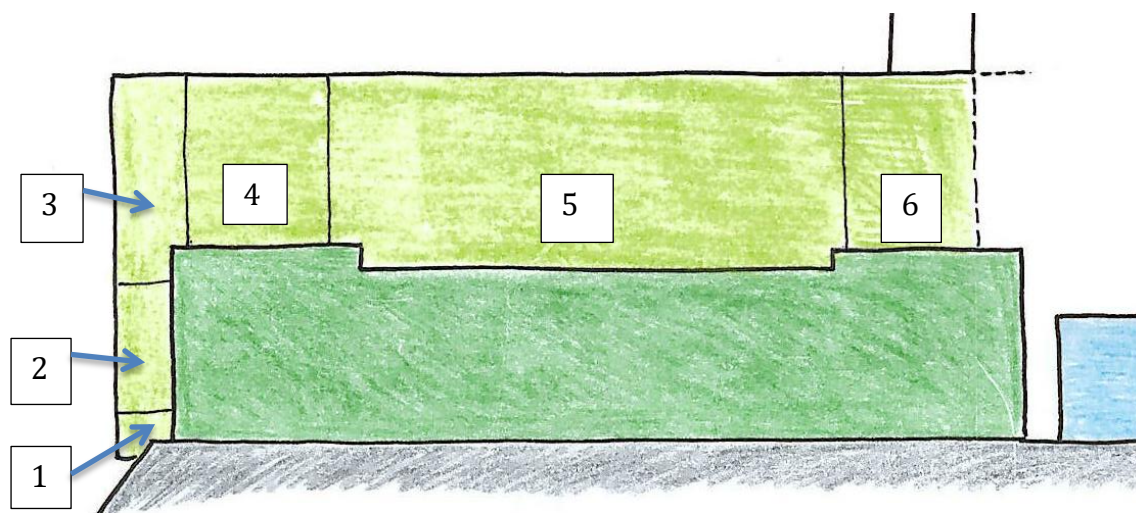
Plate 9: Scale plan of the base step showing pre-fabricated elements.

As can be seen from plates 9 to 11 above, the bottom step comprises at least 6 panels as seen now. They seem to comprise two types. There is the main one to the front which depicts a vase with large scrolls of flowers and leaves. As seen now it is 1590 x 565mm in plan, but it has been truncated to the left side, and cut in around the plinth. The second design is with a brightly coloured vase with a more compact flower composition, rectangular but closer to square, with a black background and red border. These panels appear to be cut up to fit around the edge in a rather makeshift way. I guess that this might be 'original' since there is no sign of panels being cut twice, but it is conceivable it was made this way in a previous restoration. The left-hand side is now covered by a carpet, which has been put there since I photographed it in 1998 (plate 11) but before Simon Swann photographed the monument in October 2016. It looks like the carpet actually only covers a little more than the sanctuary floor tiles did, and we have no clues as to whether more survives under there.

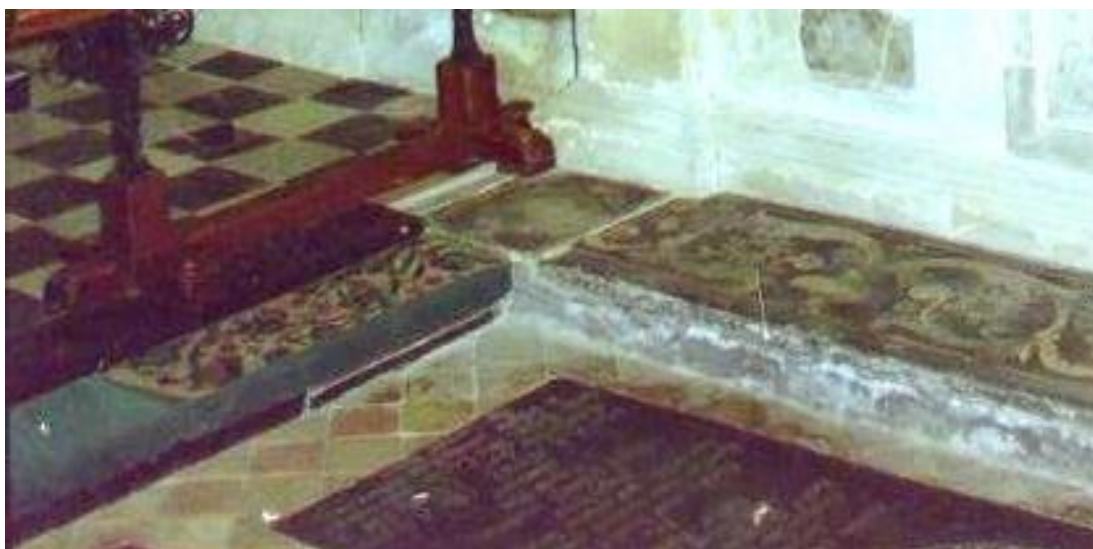
Plate 11: Detail of the bottom step as seen on 21 March 1998 (photograph by David Carrington).

This is larger and thicker than the other panels, with a different pattern. Mechanical damage to the front right-hand corner – looking quite recent – and slightly older damage to the front left-hand corner (it looks to be present in my 1998 photograph, plate 11). There is a crack running front to back in the left centre, and there is an area of cracking to the front edge in the centre. The right hand side of the panel at the front sounds hollow. The pointing to the rear is in black mortar.

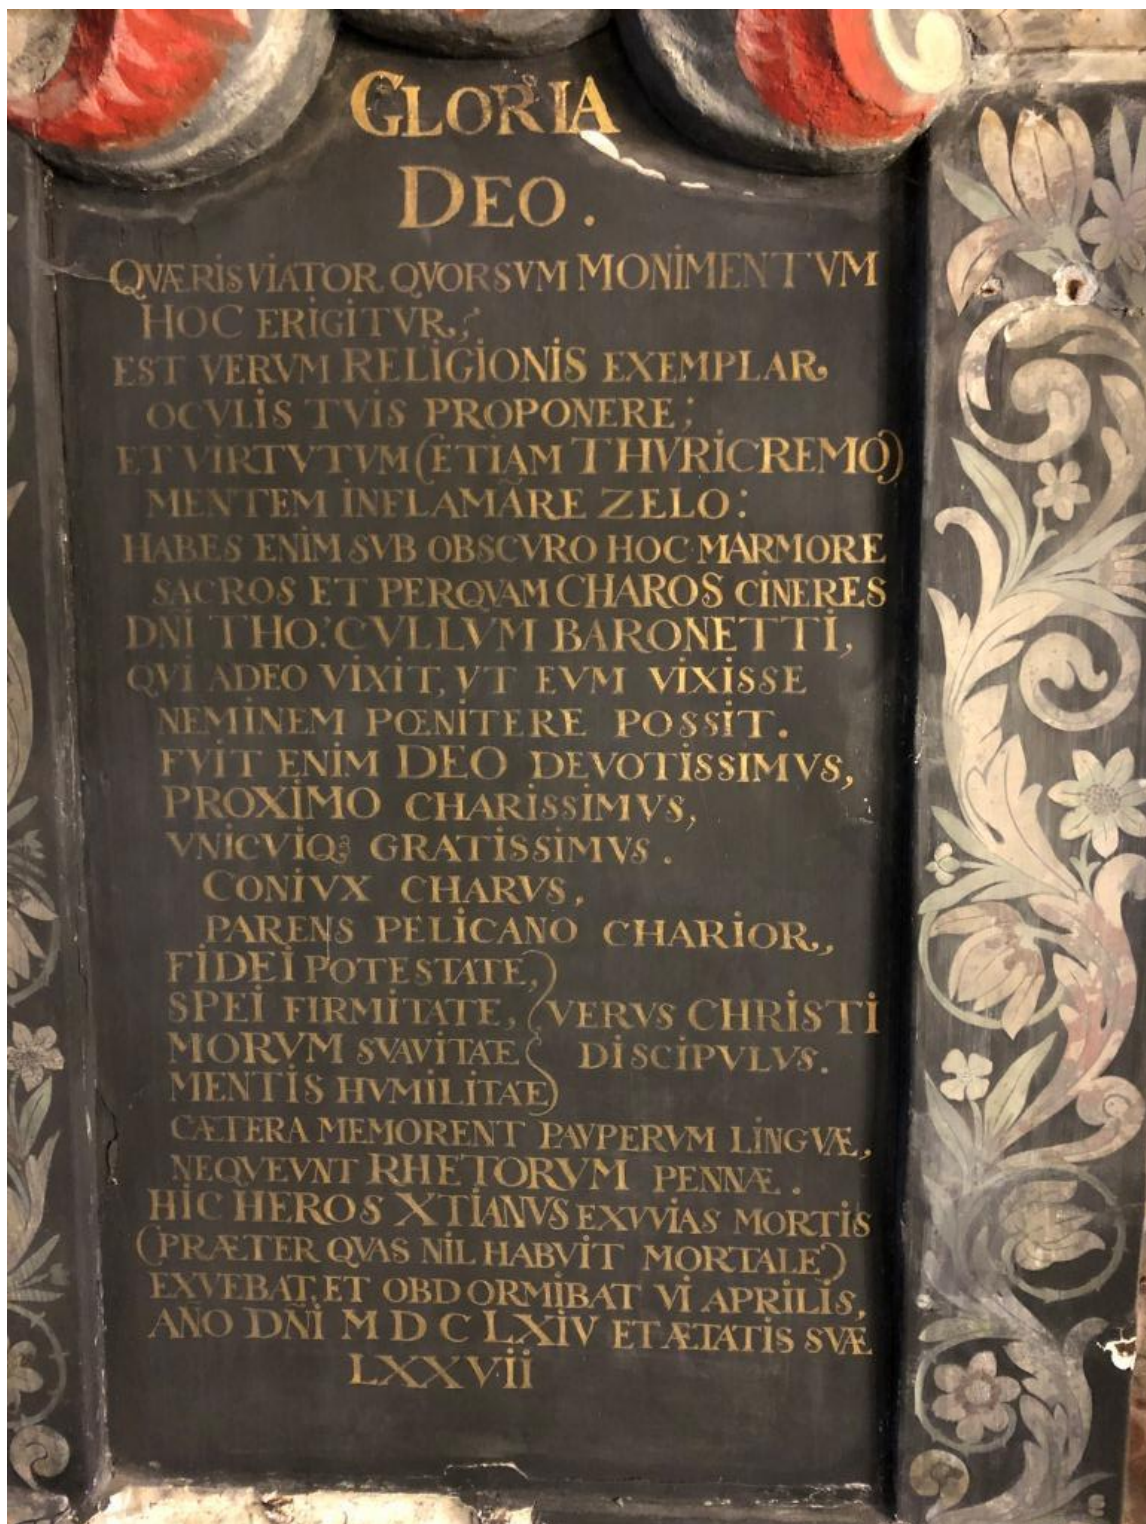
Plate 18: The inscription panel.

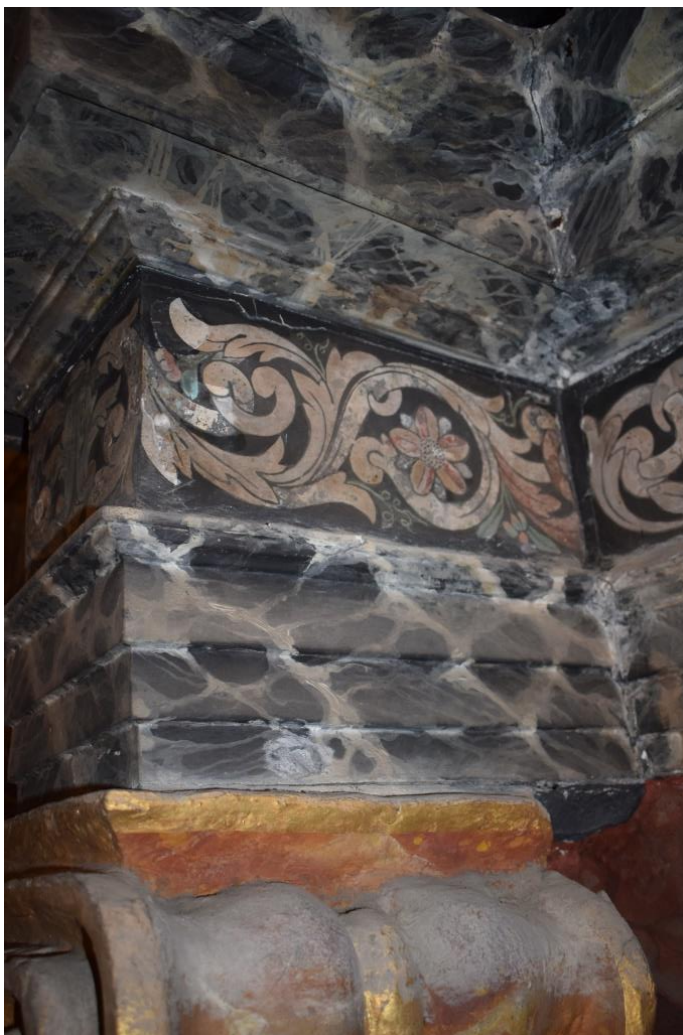
Plate 19:
Detail showing the
cornice, frieze and
architrave blocks above
the left-hand side capital.
Note the marbling and
the scagliola patterns.

- 5.5.2 The cornice can be seen in detail in plates 19 and 20. There are two main issues of concern. Firstly, as we have seen in section 3.2.5, the cornice is made up of large pre-formed units with iron reinforcement, and in places there is localised surface disruption where this is corrosion. See plate 46. Secondly, there are localised fractures associated again with ironwork, but this time with fixings holding panels in place. See plate 47.

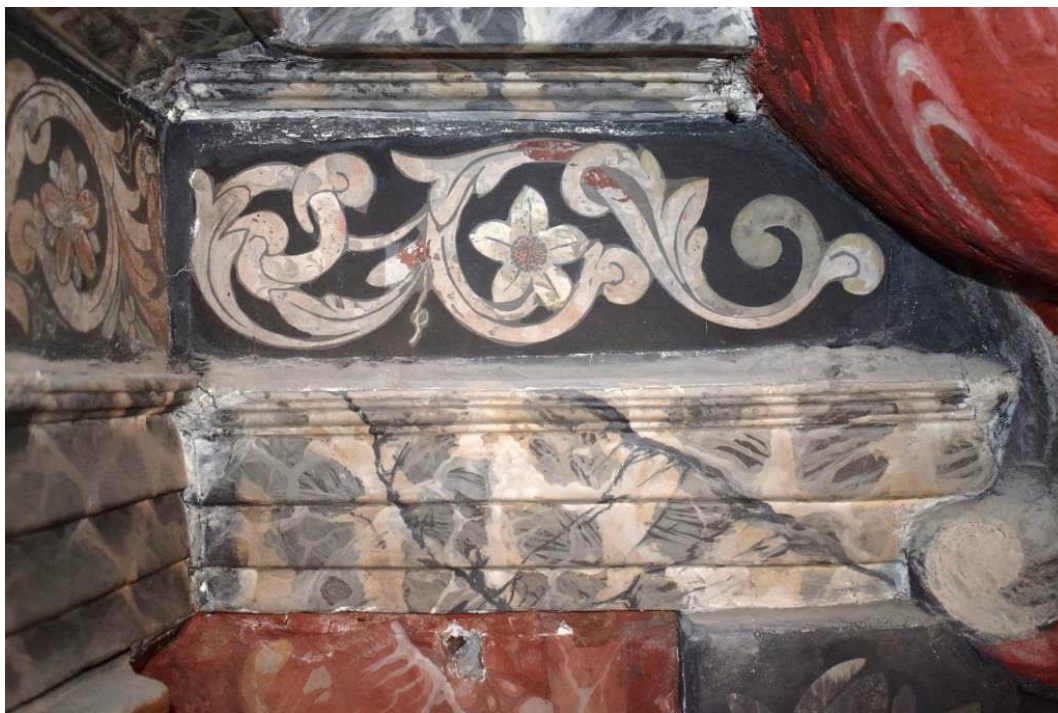
Plate 20: The frieze and architrave to the left of the central cartouche arrangement

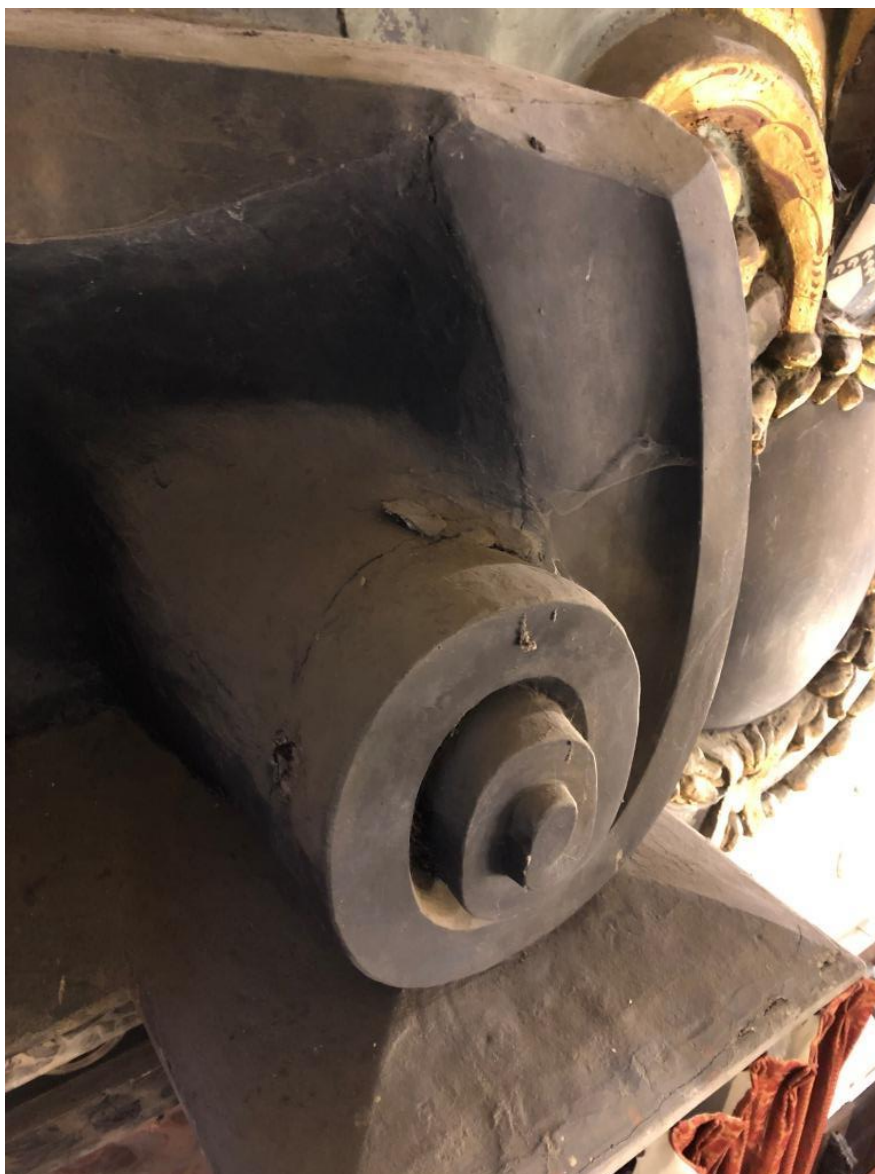
Plate 25: Detail showing the right-hand scroll. Construction joints can be seen as well as the plaster flaunching on top of the cornice.

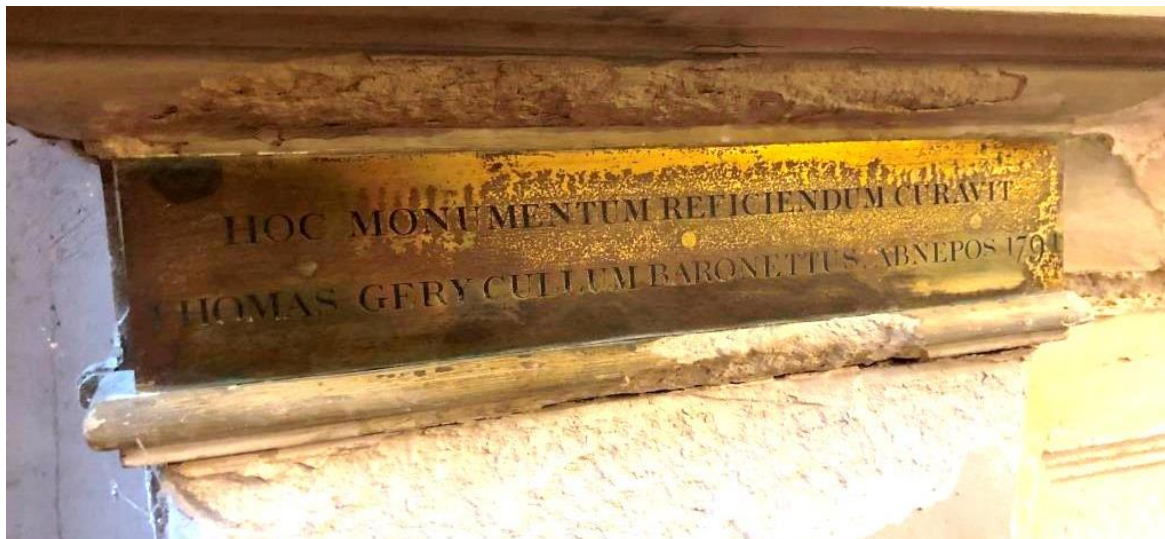
Plate 26: A brass plaque on the left side of the base section, just below the cornice, records: HOC MONUMENTUM REFICIENDUM CURAVIT/THOMAS GERY CULLUM BARONETTUS ABNEPOS 1794.

As recorded in a brass plaque (see plate M above) the monument was restored in 1794. We can surmise that there was extensive restoration to the paint, and that some, or even much, of the mortar repairs to (for example) the base section could date to this intervention. More on this is evidenced by Catherine Hassall's report on the polychromy (Appendix A). Here gypsum plaster is found under restored paint, typically with original colour lost. Re-painting was found to be present in all 10 samples analysed, and this found to be the only evidence of colour restoration present. Original gold leaf on the lion was over-painted with fresh yellow oil paint of iron oxides and lead white, then a yellow oil size containing yellow ochre and lead white applied, then gold leaf applied (sample A). The scagliola, originally black 'marbled', was restored by painting black and then applying white streaks in pure lead white paint (sample C). Original red was overpainted with pure vermilion (e.g. sample E). The green had a dark underlayer of carbon black and lead white overlaid by a green glaze-like top coat of carbon black mixed with a yellow pigment (sample B). There was possibly some 'bronzing' (sample G). Elsewhere red iron oxide paints were used. There is some evidence of a varnish on original paint layers and underneath the restored paint. It is not clear if this is 'original', dates to between 1675-1794, or was part of the 1794 restoration, but it cannot be later.

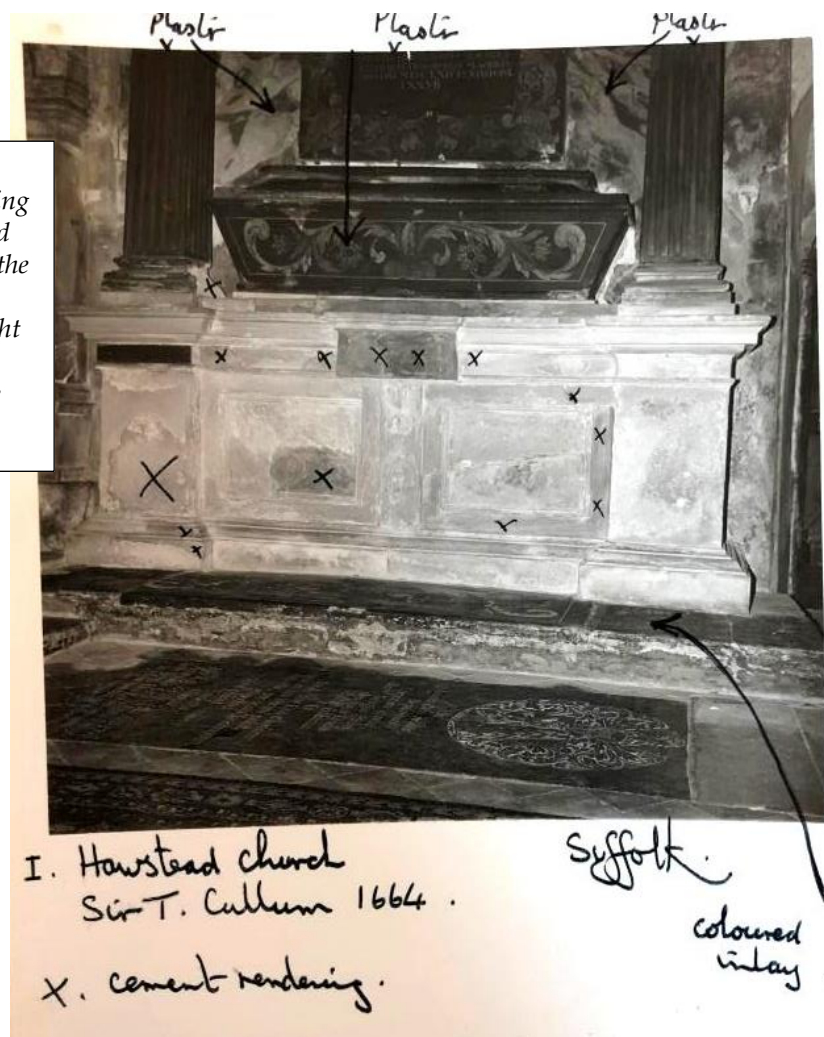
Plate 51: Photograph believed to be accompanying John Green's report, and thus dated to 1975, from the CERC archive file CARE/33/325. (Copyright permission for further reproduction should be sought from CERC).

In general very good, the monument has been washed down at sometime & the black paint has been smeared over some of the coloured work ie. On coffin & panels round inscription.¹⁶

From this it is clear that much the same as has been noted in the present survey was also evident in 1975, although I don't recognize the columns as cracking – other than in a very minor way.

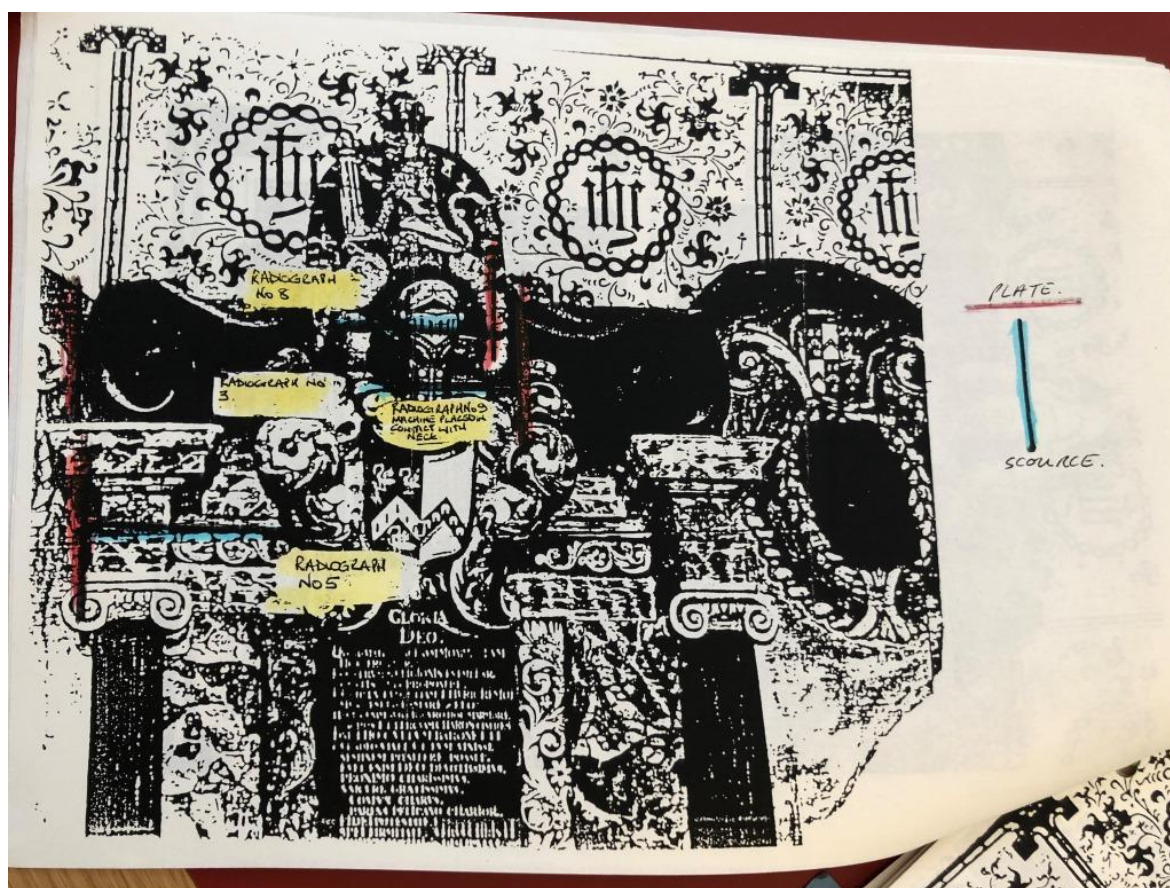
Plate 52: Copy of an annotated photo from the X-Ray survey report of 1993, from the CERC archive file CARE/33/325. (Copyright permission for further reproduction should be sought from CERC).

- 5.7.2 With no action as such having been taken as a result of Green's report, another conservator, Paul Harrison of the Northamptonshire firm Harrison Hill Ltd, made a survey in 1992¹⁷. This was followed up by an attempted X-ray survey in February 1993¹⁸, which had only limited success due to the thickness of material through which the X-rays had to penetrate. An example of the angles taken is shown below.

Harrison describes the same basic deterioration patterns that we see today, highlighting the corroding iron fixings, as well as problems caused by rising damp and condensation. I failed to see much evidence of condensation personally, but perhaps the more concerning error was the description of the sarcophagus as being of Carboniferous limestone. He also notes movement to the columns, with 'subsequent gaps being pointed on the surface and re-painted' – which I think must be the cracking to the

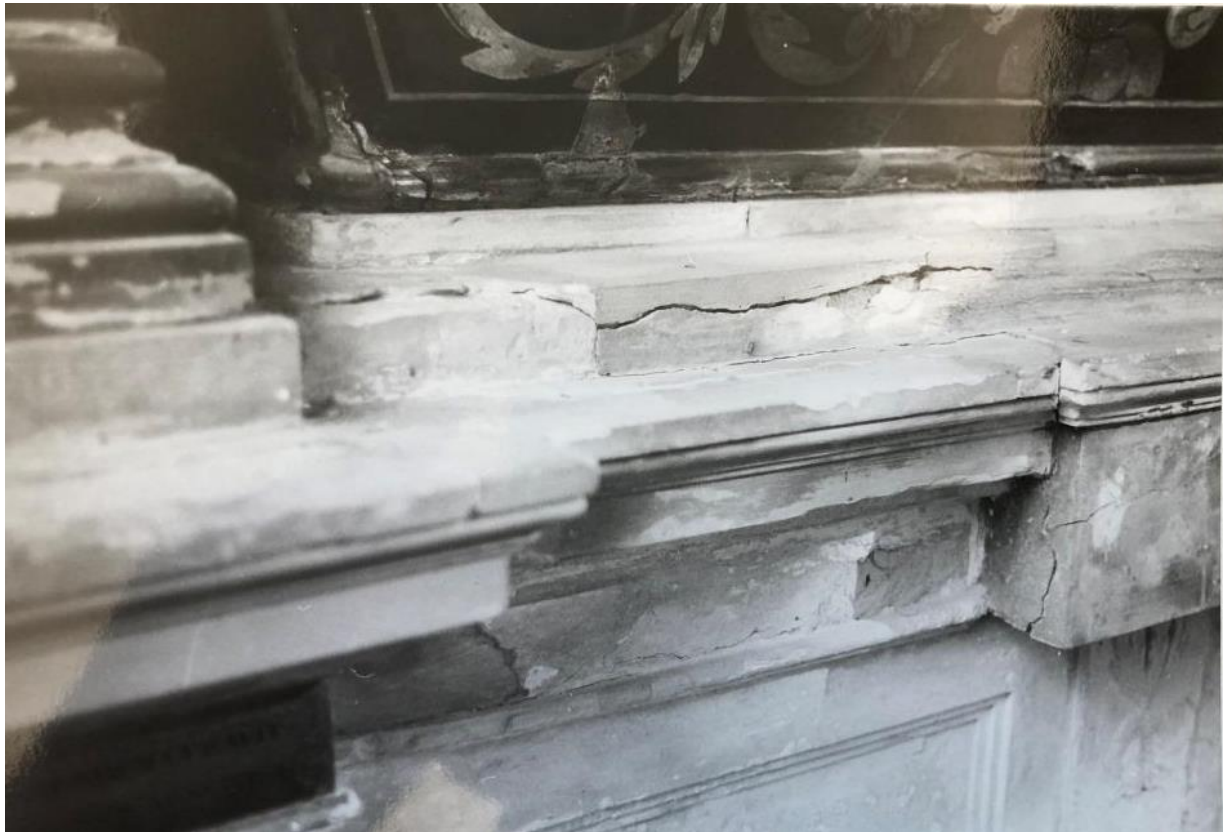
Plate 53: Copy of a photo by Paul Harrison as part of his 1992 survey, from the CERC archive file CARE/33/325. (Copyright permission for further reproduction should be sought from CERC). Compare with plate 10 on page 14, and plate 37 on page 38. The base to the sarcophagus is clearly deteriorated in 1992, but appears worse today. Similarly the square cement 'block' at the top centre of the plinth is already cracking.

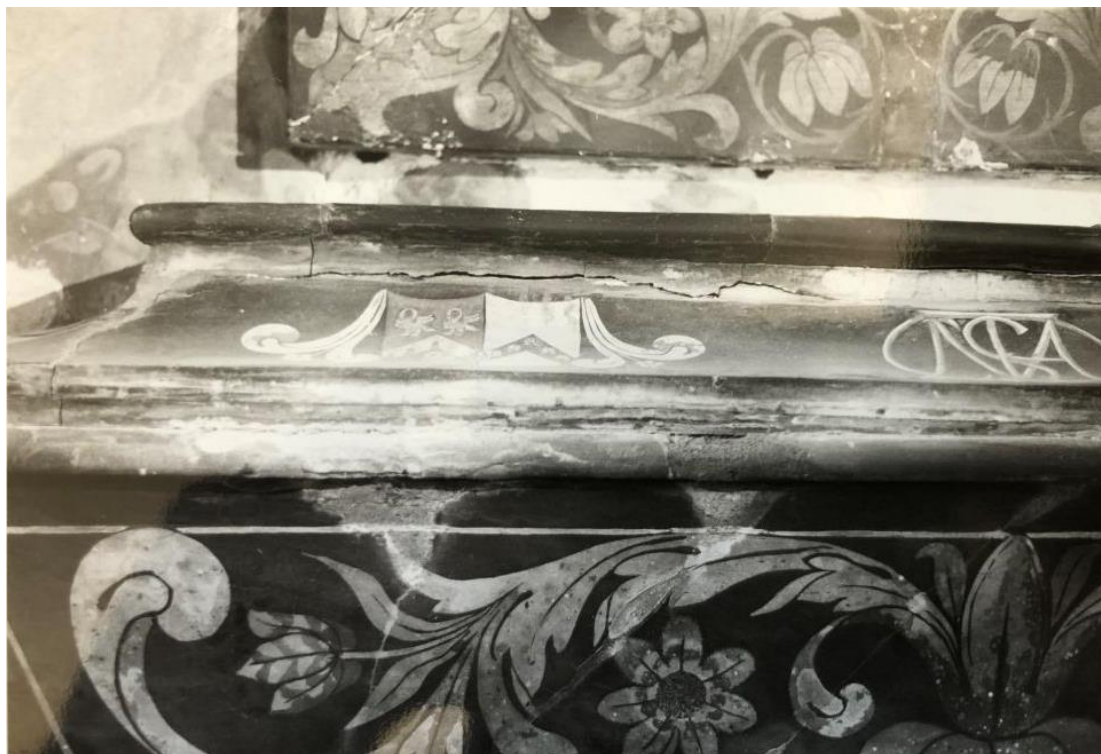
Plate 54: Copy of a photo by Paul Harrison as part of his 1992 survey, from the CERC archive file CARE/33/325. (Copyright permission for further reproduction should be sought from CERC). Compare with plate 55, below, taken in 2020.

Plate 55: Photograph taken in October 2020 showing the same area. Although the disruption to the top of the sarcophagus was evident 28 years ago, it does appear more pronounced today.

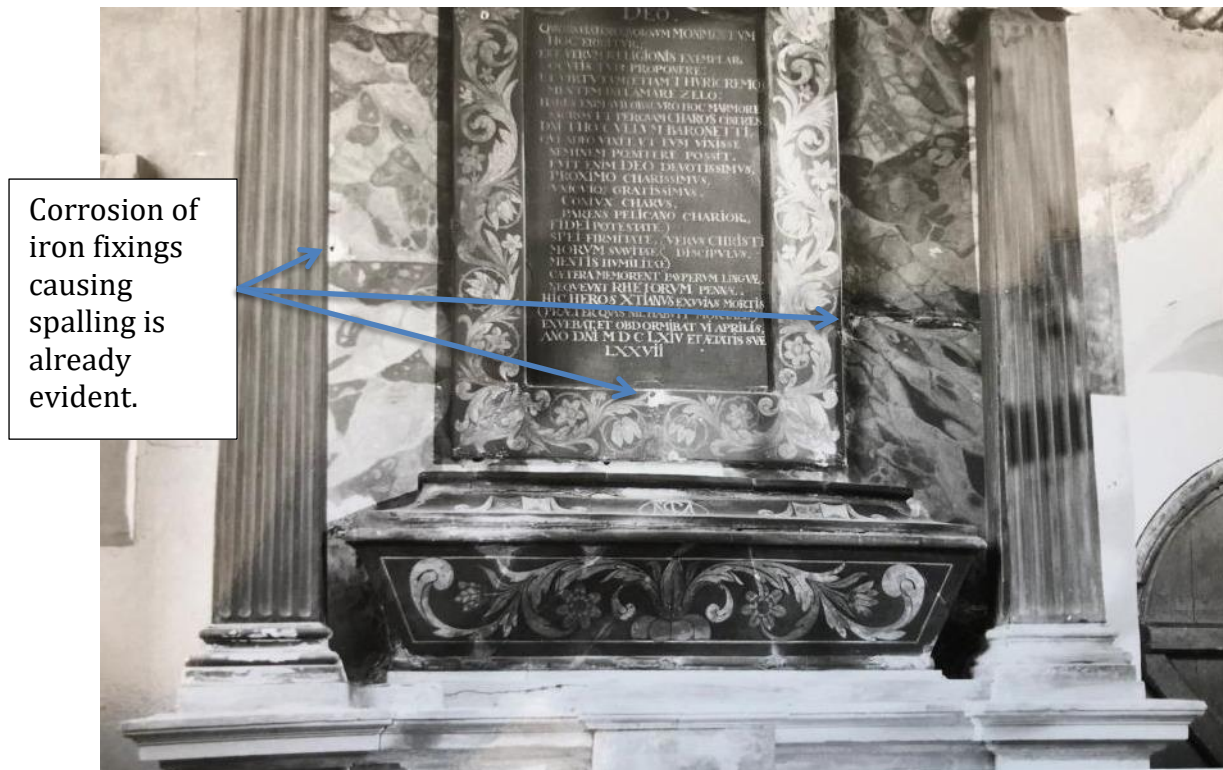
Plate 56: Copy of a photo by Paul Harrison as part of his 1992 survey, from the CERC archive file CARE/33/325. (Copyright permission for further reproduction should be sought from CERC). Compare with plate 56, below, taken in 1998, and plate 44 (page 45).

Plate 57: Detail of an image taken by myself on 21 March 1998. The angles are slightly different and there is some shadow in the 1992 photos, but there is not much discernible difference. The spalled plaster on the back panels is already present in 1992 (indicated on plate 56) and the lower frame sections, displaced by 2020 – and indeed in 2016 where shown as such in Simon Swann's report proposal – are still in place.
